# AEROPRAKT INFORMATION BULLETIN

## VIBRATIONS OF THE MAIN LANDING GEAR LEGS OF A-22LS AND A-22L2 AIRPLANES. IB A-22LS-01

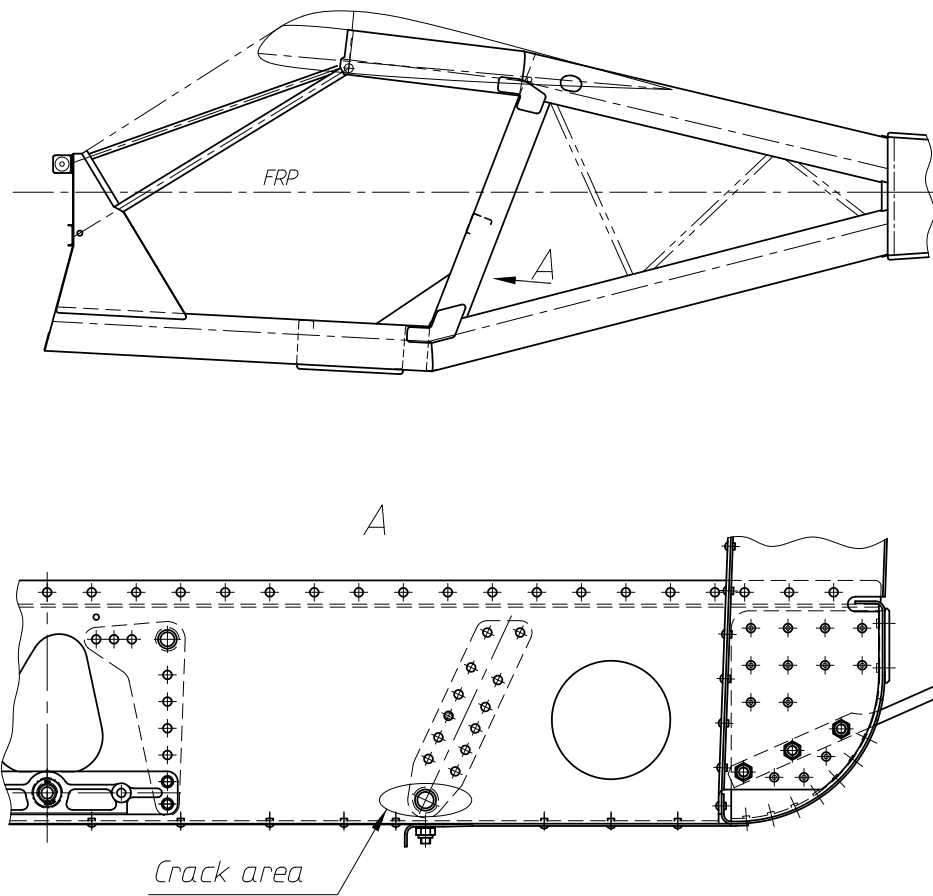
**Fig. 1**

It was found out that an energetic braking on a hard surface runway causes resonance vibration of the main landing gear legs. The vibrations in their turn cause elastic oscillations of the bottom fuselage skin in the area of the outer lower attachment fitting of the main landing gear leg, which may result in fatigue cracks in the rear web of the transverse beam of the main landing gear attachment. To reduce the probability of crack creation it is necessary to increase the stiffness of fuselage skin in the area of the attachment fittings of the main landing gear using the reinforcing angles. **It is strongly recommended to avoid the resonance vibrations of the main landing gear.**

1. Inspect the beam for cracks in the specified (see fig. 1).

If cracks are found it is necessary to perform the repair work according to p. 3.1.2, otherwise carry out inspection regularly.
