BRITISH MICROLIGHT AIRCRAFT ASSOCIATION SERVICE BULLETIN

Reference: BMAA Service Bulletin 2443 Issue 1
Title: Inspection of Kievprop composite propeller blades
Applicability: All Kievprop composite propellers
Authors: Adrian Jones & Ben Syson, BMAA
Effective date: 1 August 2013
Classification: Advisory

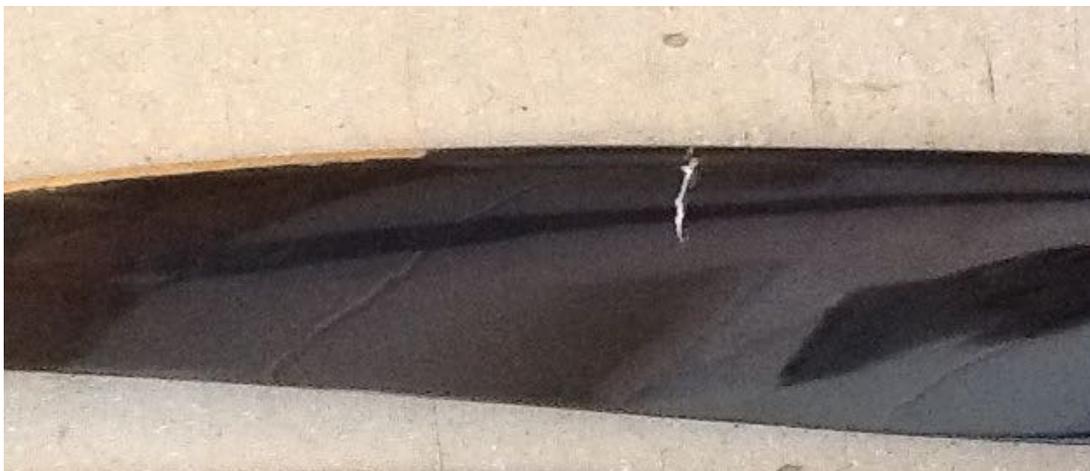
The BMAA has received 2 reports of transverse cracks on Kievprop type 283 (tractor) blades similar to that in Figure 1. This damage may be caused by overload in bending caused, most likely, by hangar rash. It is also possible that the cracks could be fatigue cracks caused, for example, by extended rough running with carburettors poorly balanced, or engine starting problems being left unresolved.

Figure 1 – transverse crack Kievprop on propeller blade

Operators – of all Kievprop propeller types – should be aware of these potential damage types when inspecting the propeller. Propeller inspection should form part of the normal pre-flight inspection.

If damage is found the aircraft should not be flown until replacement propeller blades are fitted. Owners are requested to report any damage found to the BMAA.

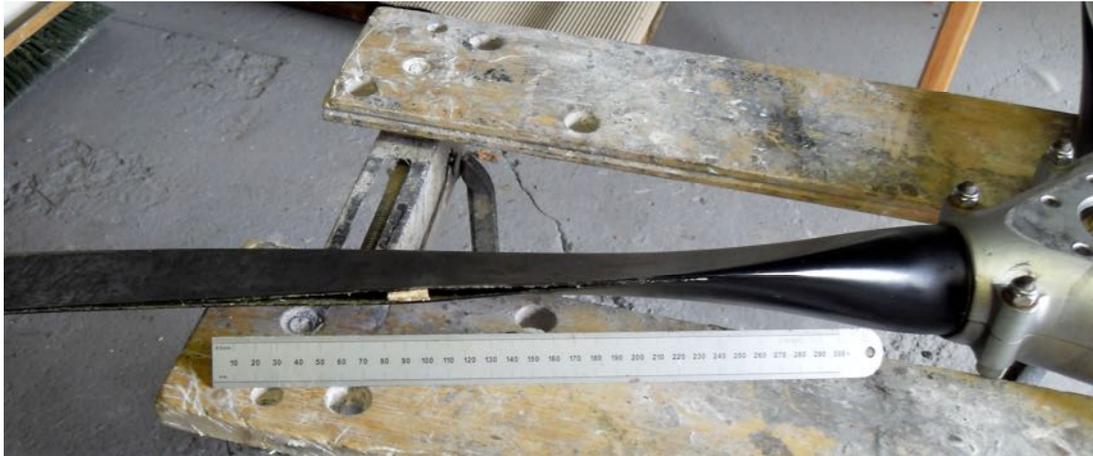
A small number of Kievprop propellers fitted to BMAA aircraft have suffered delaminated trailing edges as shown in Figure 2.

Figure 2 – delaminated trailing edge

Trailing edge cracking can occur from moisture in the (hollow) blade, especially if it freezes. The blades come with a vent hole at the tip, but this can get blocked over time.

The drain holes should be checked periodically, and cleaned out if blocked.
