Australian Ultralight Federation Inc

9 November 2001

Alert - Warp Drive Propellers - Power Absorption Capacity

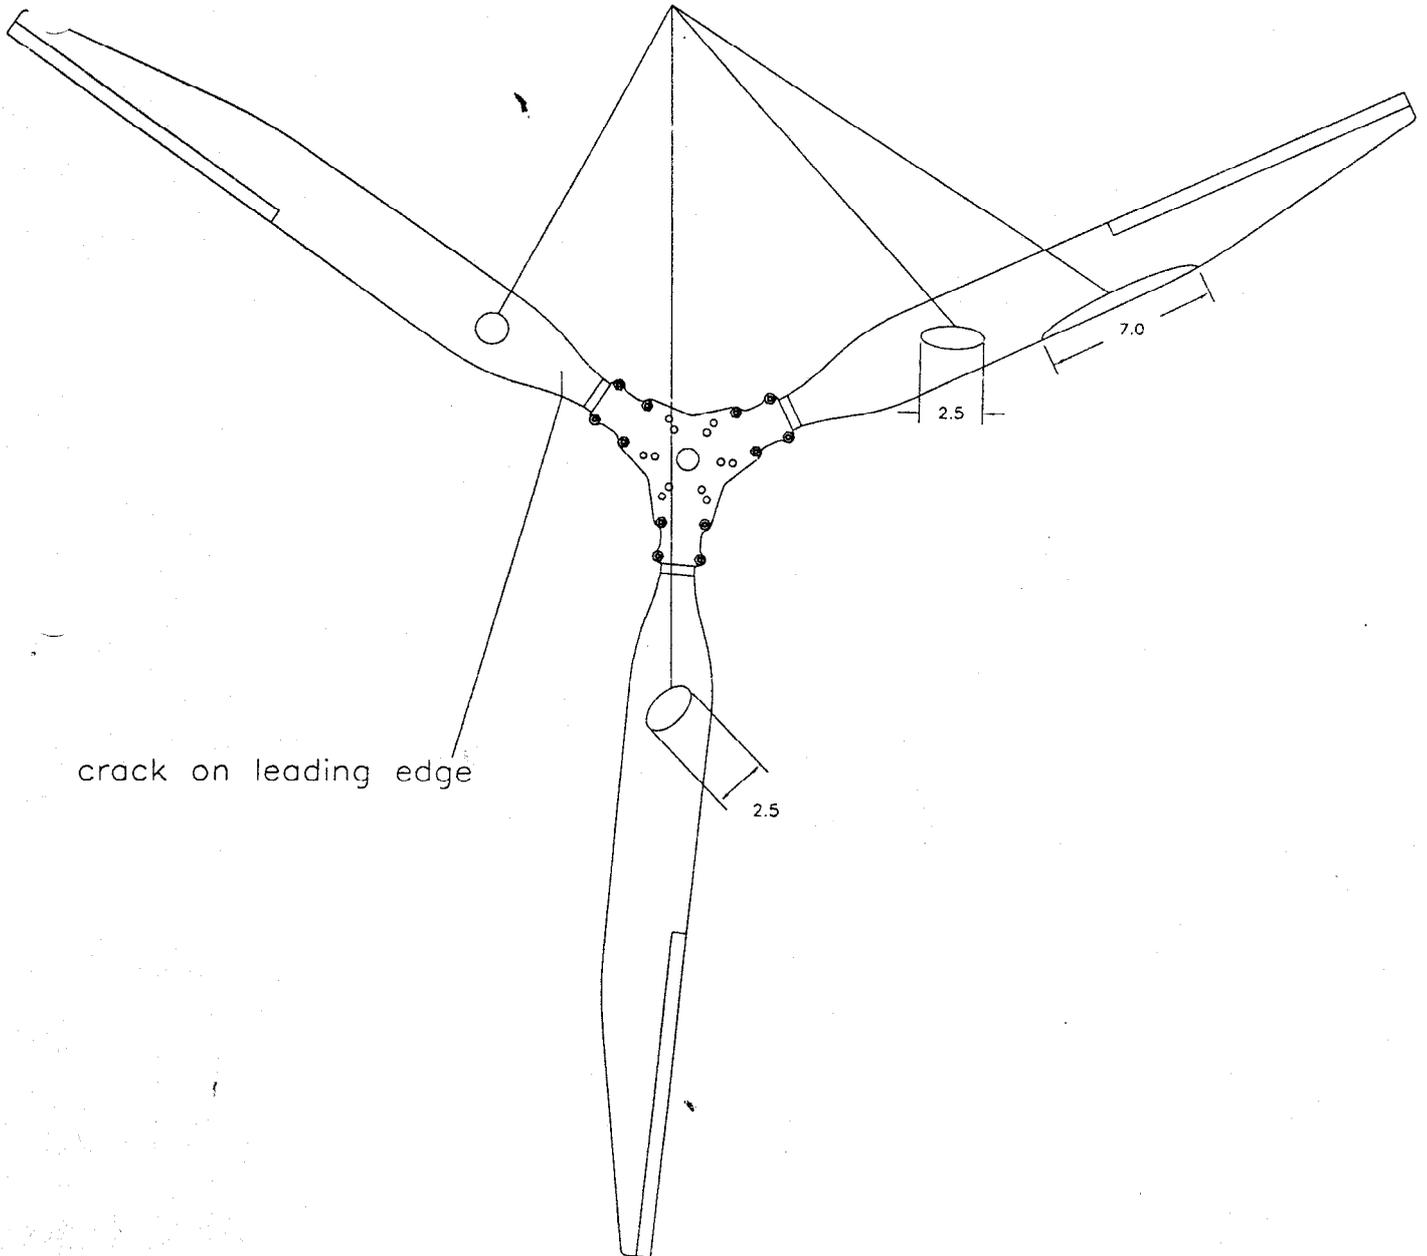
Areas of delaminating found on our factory demonstrator

3 blade 72" dia. tapered
on RANS S-16 factory AC
with 200 hrs. since new.
Engine Continental IO-240
(125 HP)

Pitch
13.2deg.
on tip

areas of delaminating

- Anyone operating an aircraft with a two bladed Warp Drive propeller driven by an engine capable of delivering more than 100HP should cease using it and change the propeller type.
- Anyone using a three bladed Warp Drive propeller on an engine capable of 100HP or more (not only Rotax) should perform a thorough inspection of the hub and blades at least every 25 hours
