AEROPRAKT INFORMATION BULLETIN

INSPECTION AND REINFORCEMENT OF A-22L AIRPLANE STABILIZER SKIN.

IB A-22-10

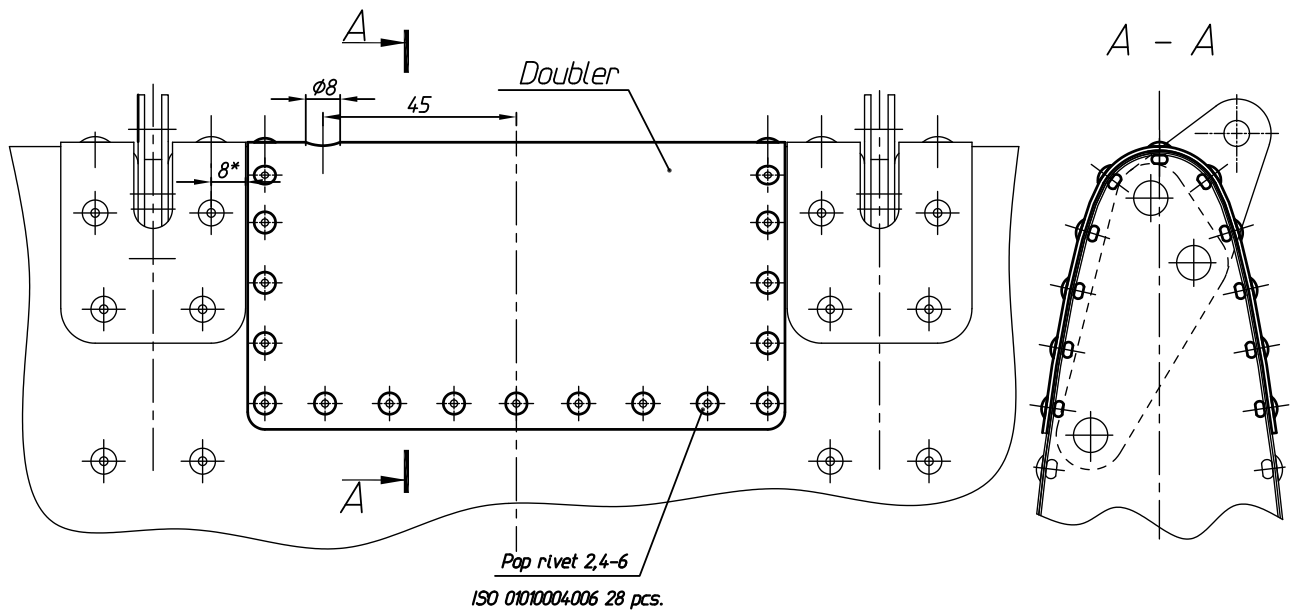
4) **Appendix:**
Drawing of the reinforcement.

It was found out that the probable reason of stabilizer skin cracking in the vicinity of the opening for the trim tab control cable was caused by the fatigue damage due to intensive operation of the aircraft.

1. Drill the crack ends using Ø2.5 drill and de-burr the hole edges.
2. Put the doubler (1) over the stabilizer skin and pre-drill it with Ø2.5 drill.
3. Remove the doubler and remove the metal chips.
4. Cover the doubler with primer.
5. Fix the doubler with 28 Ø2.4 × 6 pop-rivets (2).

1. Put the doubler (1) over the stabilizer skin and pre-drill it with Ø2.5 drill.
2. Remove the doubler and remove the metal chips.
3. Cover the doubler with primer.
4. Fix the doubler with 28 Ø2.4 × 6 pop-rivets (2).
