SAFETY ALERT

No. SA A22LS-13

INSPECTION AND REPLACEMENT OF THE THREADED END OF THE ELEVATOR PUSH-ROD

Model: A-22LS, A-22L2

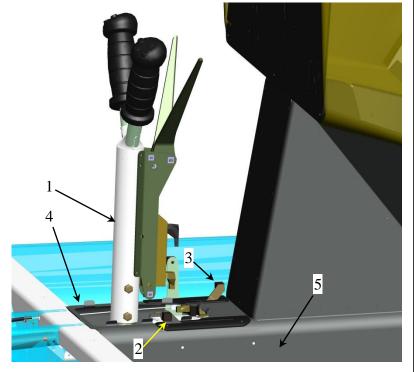
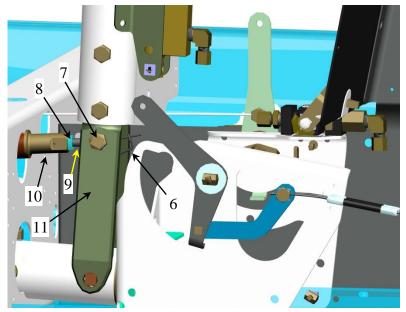
It was found out that the treaded end of the elevator control push-rod attached to the control stick of A-22LS and A-22L2 aircraft with central stick may be subjected to excessive non-design bending. This bending occurs when the aircraft is parked outside and its control stick is fixed with a locking pin passed through a hole in the push-rod and the ailerons are displaced by the wind gusts if they are not fixed by clamps (gust locks) as required in Pilot Operating Handbook, section 9.2 Towing, parking and tie-down instructions. This non-design bending may cause fatigue fracture of the threaded rod end and result in loss of elevator control in flight.

- 1. Remove the soft protecting cover from the control stick (1) and handles from the control levers of throttle, choke (2) and parking brake (3).
- 2. Remove (lift up) the horizontal panel of the instrument compartment base (4) after removing 7 screws fixing the panel to the base.

- 3. Remove the right wall (5) of the instrument compartment base after removing the screws attaching it to the floor beam (4 pcs.), seat beam (1 pc.), instrument compartment housing (2 pcs.), lower intrument panel (3 pcs.).

- 4. Unfasten and remove the locking pin (6) from the bolt (7) attaching the control push-rod to the control stick. Undo the nut (16) and take out the bolt (7), the washers (12, 15) and spacers (13, 14). (See next page.)

- ◆ Take care or some preventive measures not to loose the fasteners or drop them into the areas with restricted access.
- 5. Loosen the locking nut (8) and screw out the forward end (9) of the elevator control push-rod (10).

- ◆ To re-install the end (9) later exactly to its initial position, count turns while unscrewing it or measure some of its characteristic dimensions.

- 6. Inspect the end for deformation or cracks in its thread. If it is damaged replace for a new one.
- 7. Re-install the undamaged (or new) end with a locking nut exactly to its original position (see note to step 5).
