### **Aeroprakt Ltd**

# AEROPRAKT SERVICE BULLETIN

No. SB A32-02

## MODIFICATION OF ALL-MOVING HORIZONTAL TAIL (AMHT) OF A32 AND A32L AIRCRAFT

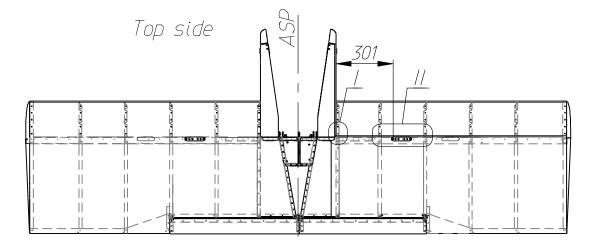
Bottom side 569

Inspect the AMHT in the area of mod kit parts installation (see detail views II and IV in fig. 1 and 2) for dents, deformation and cracks. If any damage is found in the above mentioned areas consult the manufacturer.

- Fig. 2
- 1. Installation of the top (righthand and lefthand) doublers:
- 1.1. Mark 2 holes (1 per righthand/lefthand side) on the top side of the AMHT at 301 mm distance as shown in fig. 1 and 3.
- 1.2. Drill the 2 marked holes with  $\emptyset$ 3.3 mm drill bit.
- 1.3. Install the doublers (1) on Cleco fasteners symmetrically about the aircraft symmetry plane (ASP).
- 1.4. Using the holes in the doublers as pilot holes drill  $\emptyset$ 3.3 mm holes 5 holes on each (righthand/lefthand) side.
- 1.5. Remove the doublers, deburr/blunt the sharp edges of the holes, remove the metal chips.
- 1.6. Attach the doublers with pop-rivets (3) and (4) as shown in fig. 3 (symmetrically about the ASP).
