AEROPRAKT SERVICE BULLETIN

No. SB A32-05

REINFORCEMENT OF THE FRAME No.10 OF A32 AND A32L AIRCRAFT

Model: A32, A32L

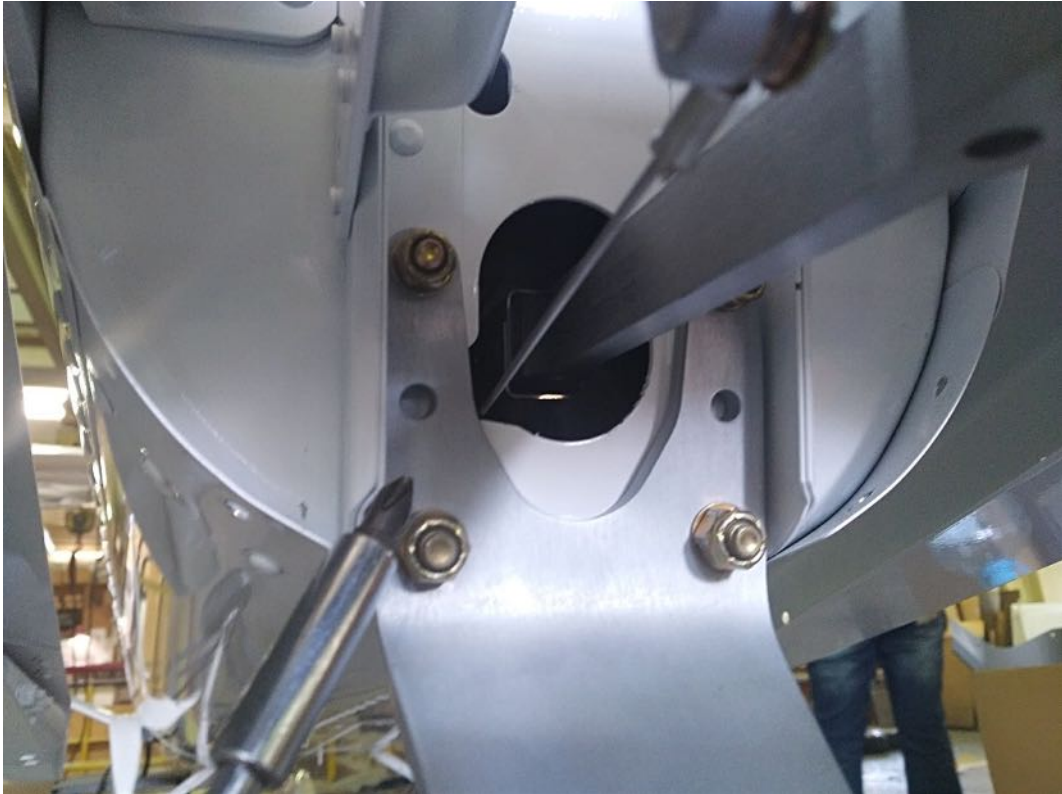
Fig. 5.

In case if excessive impact of the tail skid against the ground during take-off or landing the frame No. 10 may be damaged.

3.5) Remove the tail skid from the frame No. 10 (Fig. 5).
