# AEROPRAKT INFORMATION BULLETIN

## INSPECTION AND REINFORCEMENT OF THE RIVET JOINTS OF THE RIBS N.3 AND N.4 OF THE WING OF A-22 AIRCRAFT. IB A-22-03

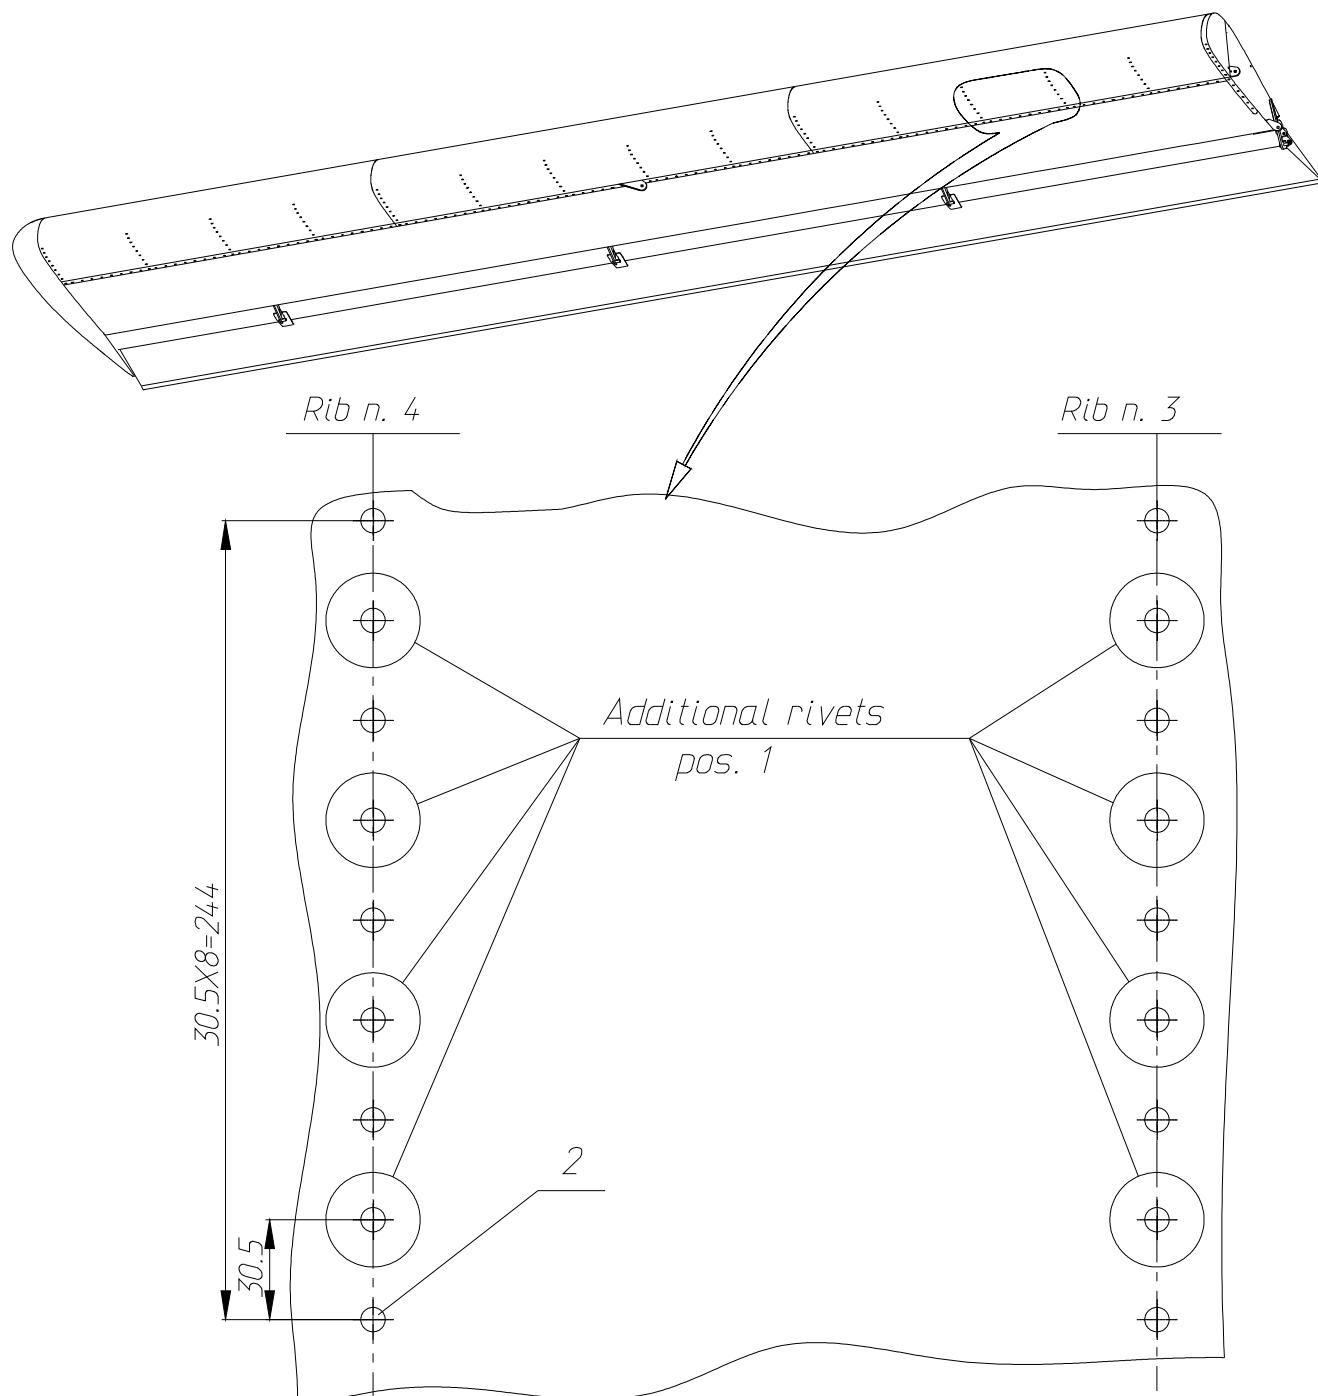
Fatigue failure of rivet heads due to cyclic loads was detected on the bottom side of the wing forward of the spar in the rivet joints of ribs №3 and №4.

Inspect right and left wings for damage of the rivet joints of ribs №3 and №4 (see fig.1). If no damage detected perform retrofit work according to section 3.1.1. In case of missing rivets or rivet joint damage in form of cracks in paint around the rivet heads perform the work according to section 3.1.2.

■ **CAUTION:** In case if the reinforcement of the specified joints of the ribs with the LE skin is not done in time, the remaining joints will fail, which later may cause collapse of the wing leading edge.

- 1) Mark the position of additional rivets;
- 2) drill Ø2.5 holes using the made marks;
- 3) remove the chips;
- 4) install the pop-rivets Ø2.4x4 BRALO; code: 01010002402 or any similar in strength rivets (shearing strength 41kg);
- 5) apply paint over the new rivets.

- 1) Drill out old rivets (item 1) using Ø2.5 drill (remove the rivet cores beforehand) and remove the chips;
- 2) mark the position of additional rivets;
- 3) drill Ø3.1 holes using made marks;
- 4) remove the chips;
- 5) install the pop-rivets Ø3x6 BRALO; code: 01010003006 or any similar in strength rivets (shearing strength 41kg);
- 6) apply paint over the new rivets.
