AEROPRAKT SERVICE BULLETIN

No. SB A32-07

REPLACEMENT OF THE NOSE WHEEL FORK HINGE BRACKET OF A32 AND A32L AIRCRAFT

Model: A32 and A32L

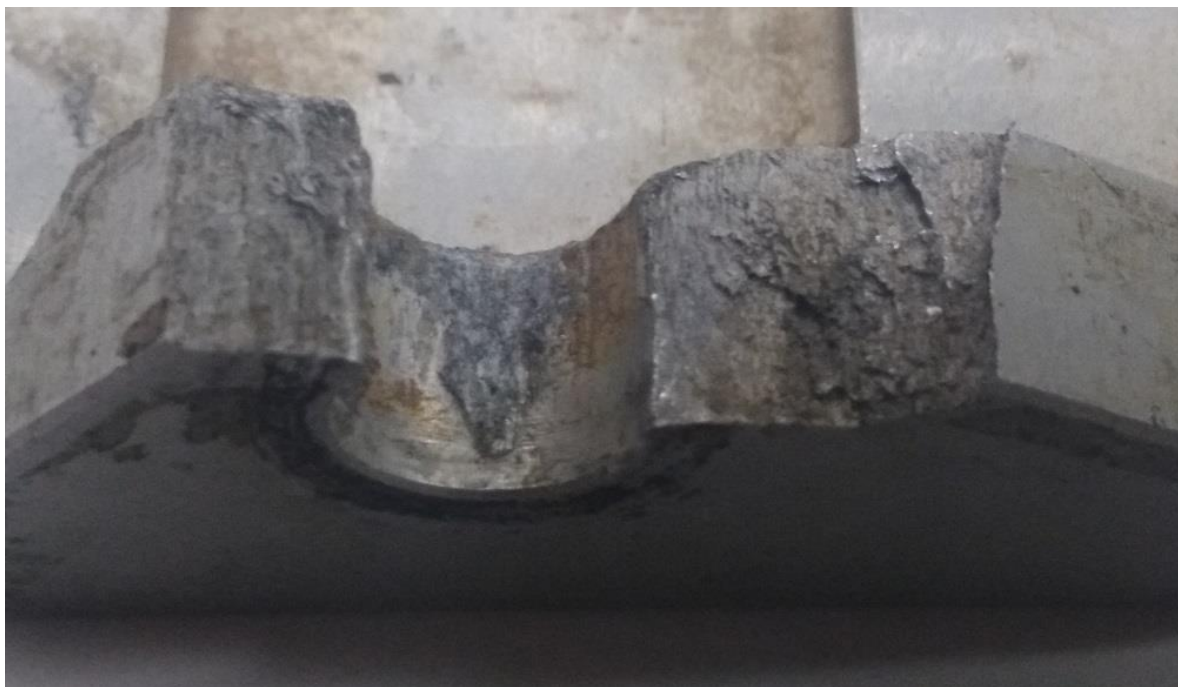
Photo 1

In conditions of high humidity and insufficient lubrication of the inner surface of the bracket hole (see photo 1) in the area of contact with the steel bolt, intergranular corrosion may appear, which affects significantly the bracket strength and may cause its disintegration.

If case if the intergranular corrosion is detected in the bracket, stop operation of the aircraft until replacement of the bracket. If there is no corrosion, continue to operate the aircraft with the bracket available, checking it for corrosion at every 100-hour inspection.
