AEROPRAKT SERVICE BULLETIN

No. SB A32-05

REINFORCEMENT OF THE FRAME No.10 OF A32 AND A32L AIRCRAFT

Model: A32, A32L

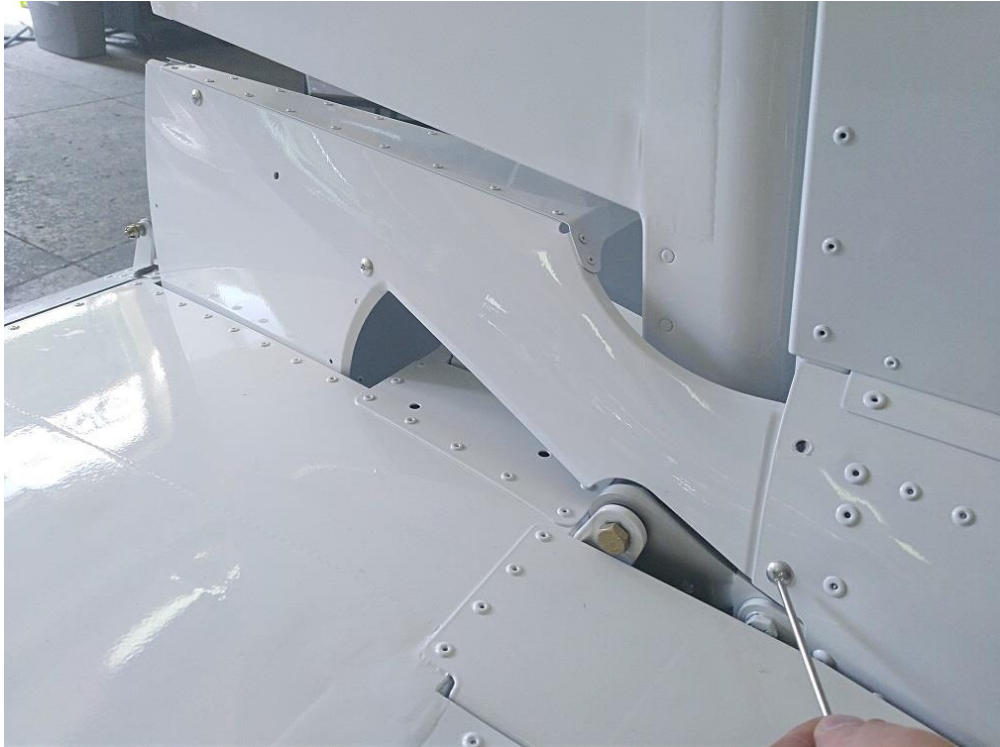
Fig. 1.

3.1) Remove the tail fairing of fuselage by undoing 14 screws (Fig.1).

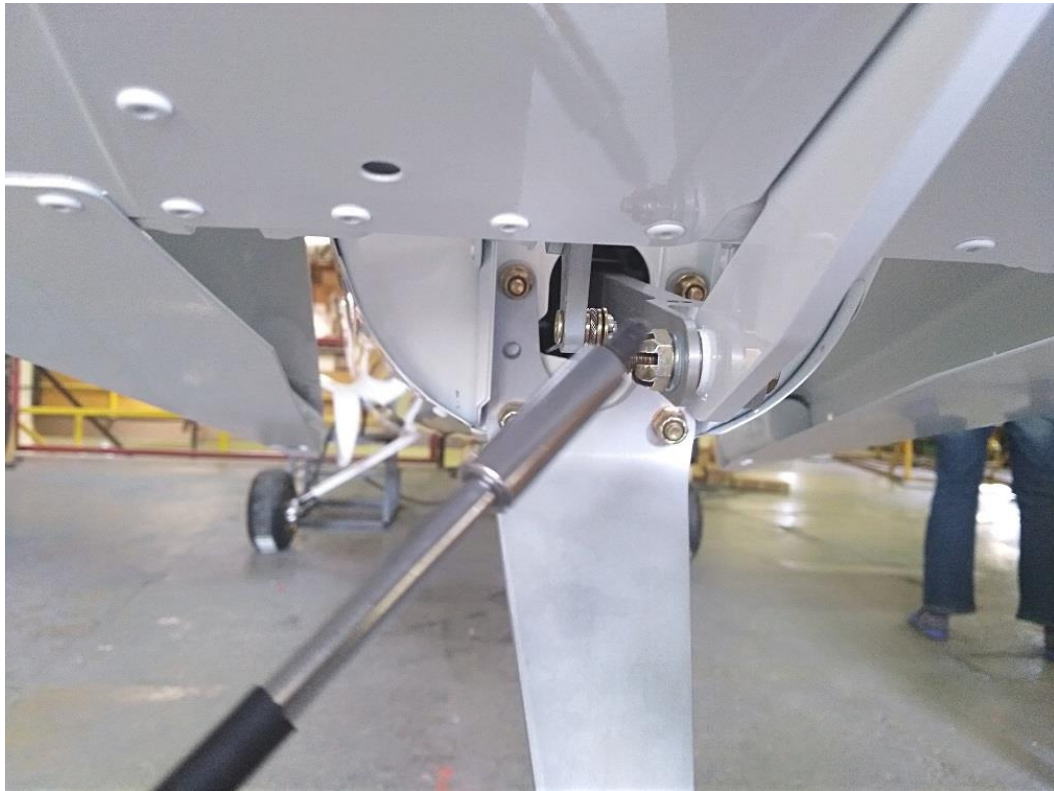
Fig. 3.

3.3) Disconnect the AMHT control pushrod (Fig.3).

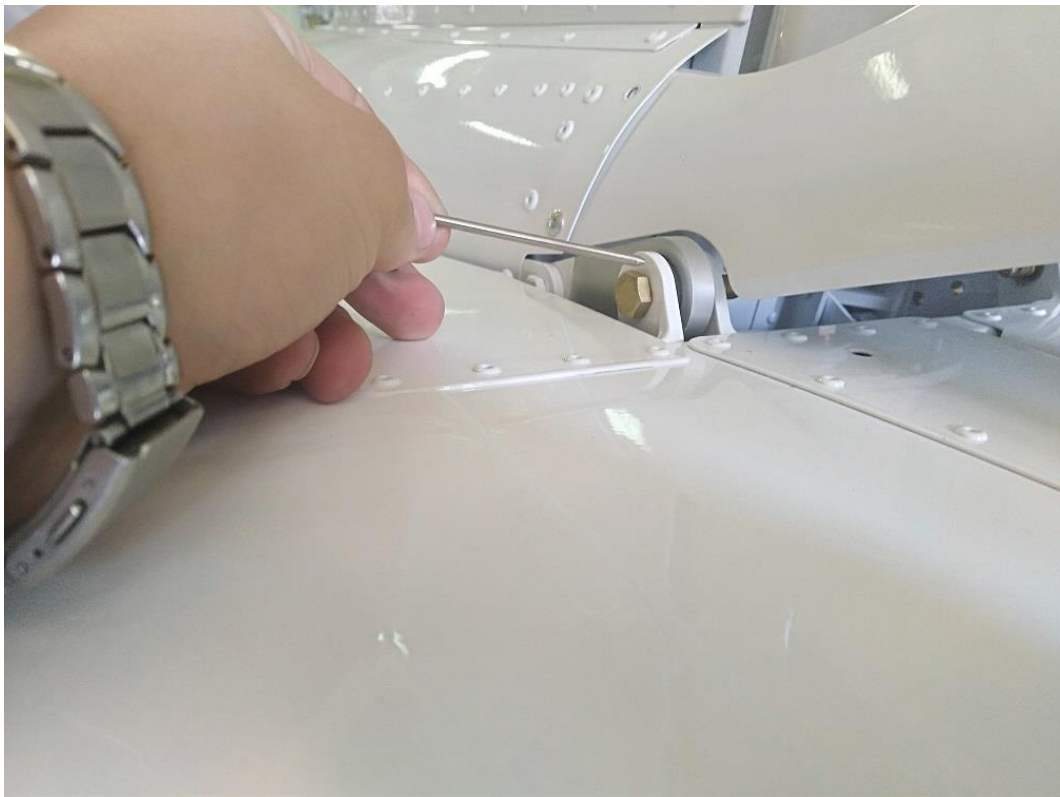
Fig. 4.

3.4) Remove the AMHT by undoing its two attachment bolts (Fig. 4).

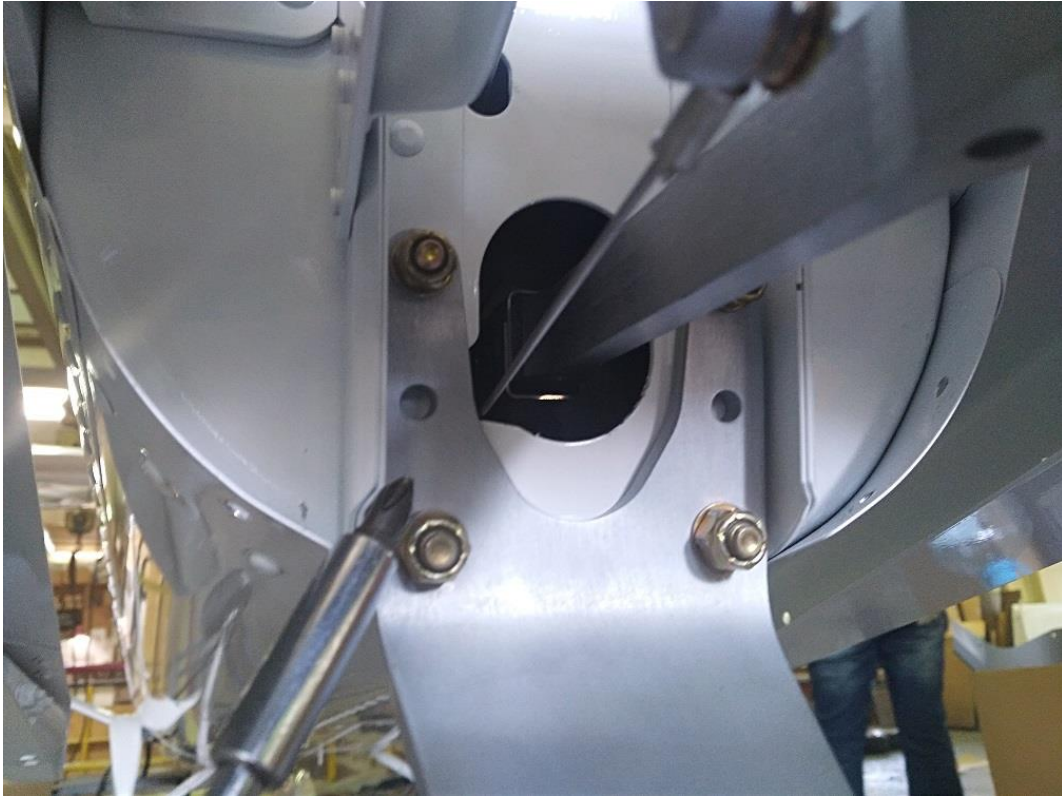
Fig. 5.

3.5) Remove the tail skid from the frame No. 10 (Fig. 5).

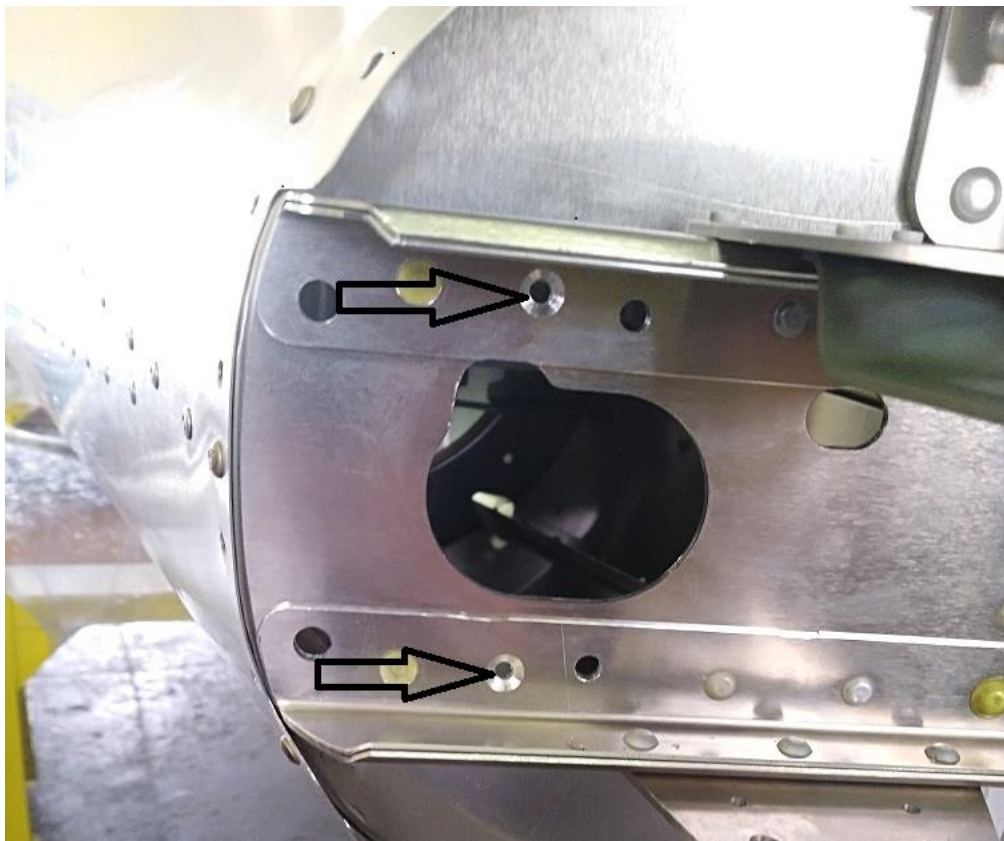
3.6) Undrill two flush head rivets marked with arrows in Fig. 6.

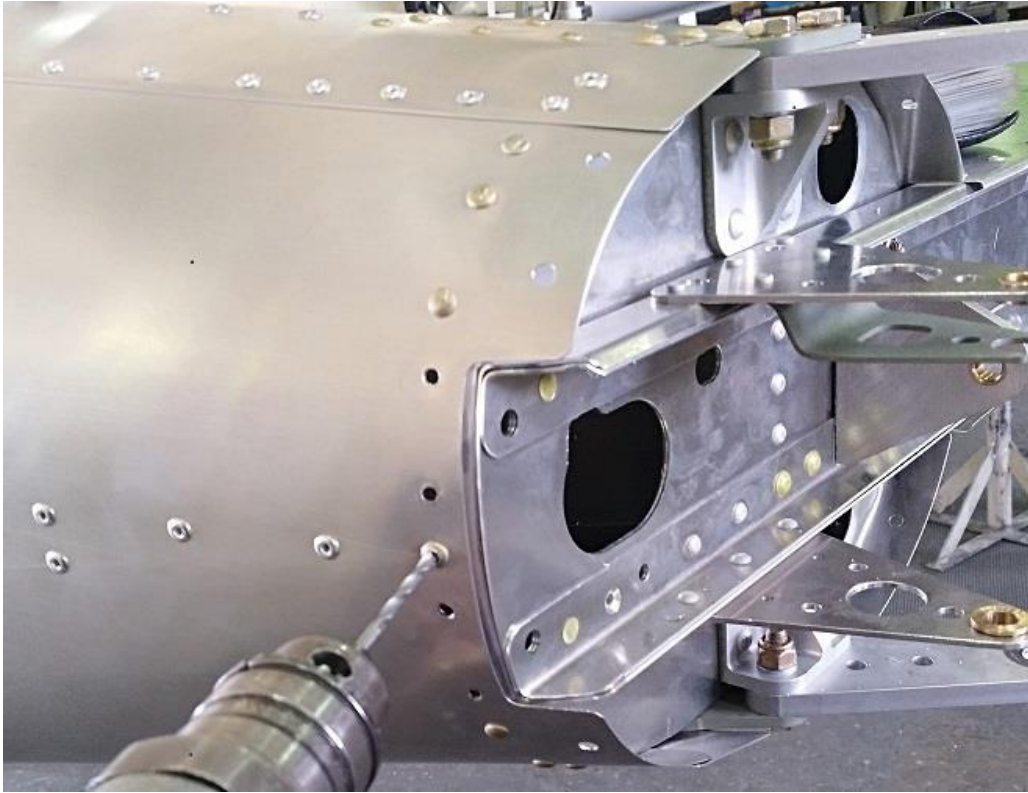
Fig. 7.

3.7) Undril 5 rivets on the bottom side of the tail boom at the frame No. 10 (Fig 7).

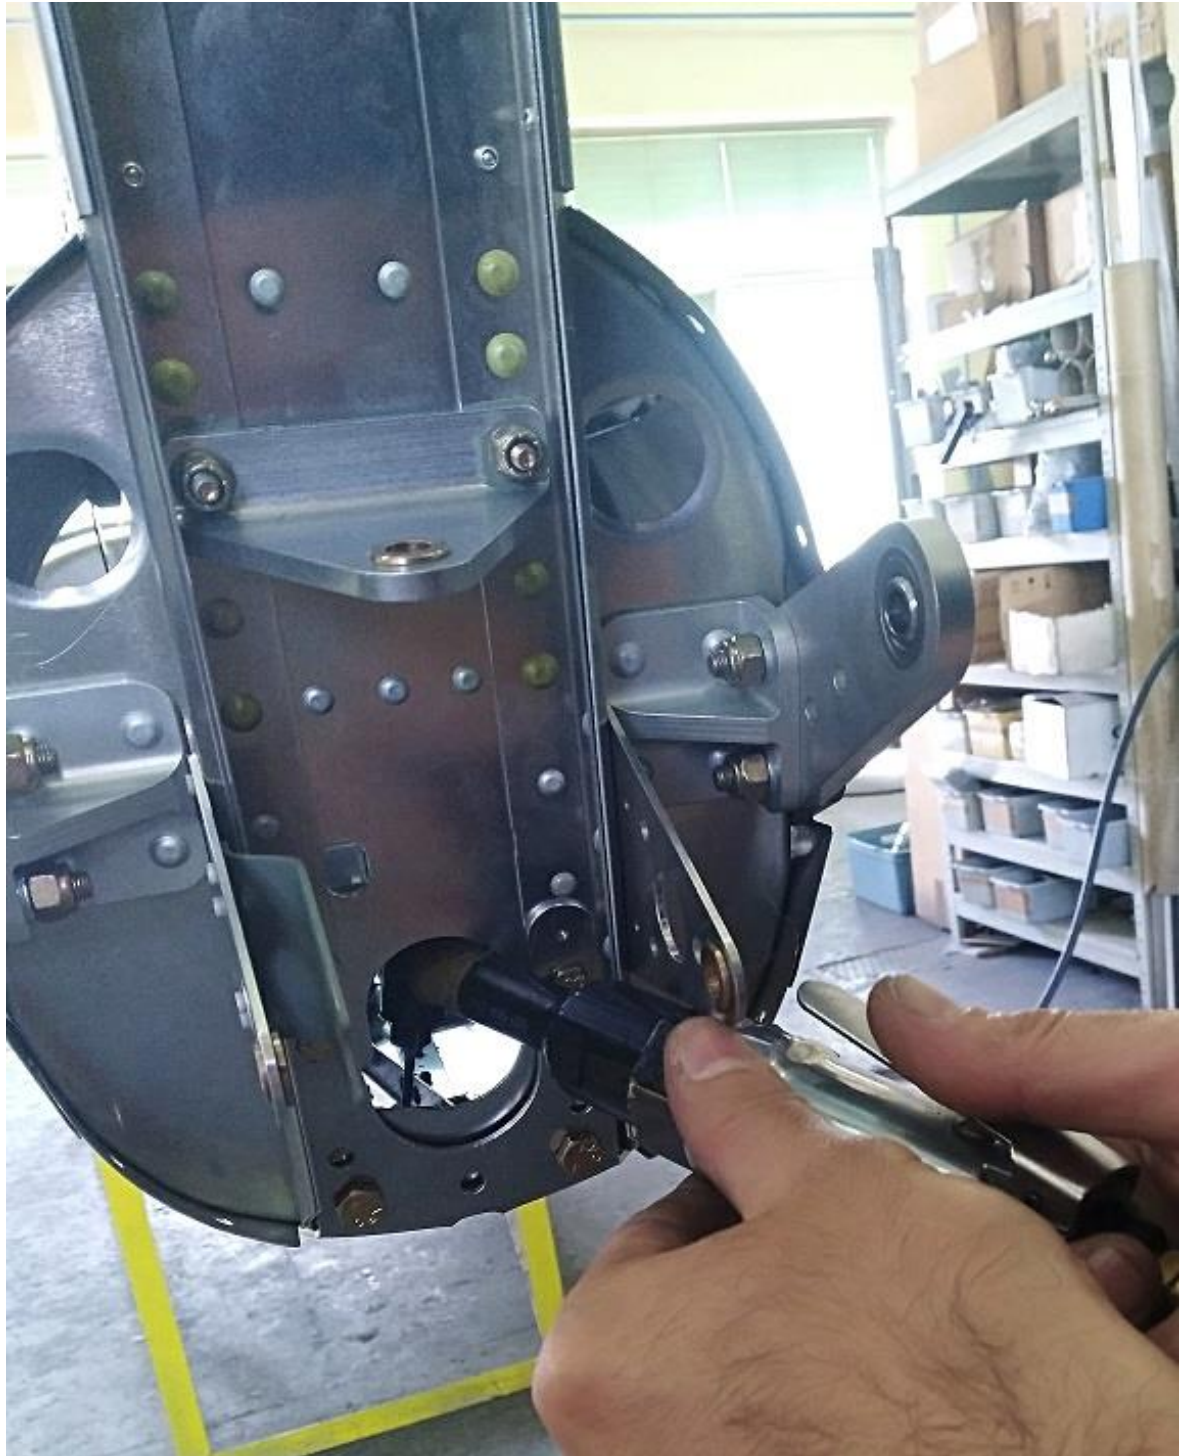
Fig. 8.

3.8) Install the reinforcing doubler with bolts as shown below, use a 90° drill to mark position of holes in the flanges of the reinforcing doubler through the holes in the frame No. 10 (Fig. 8).

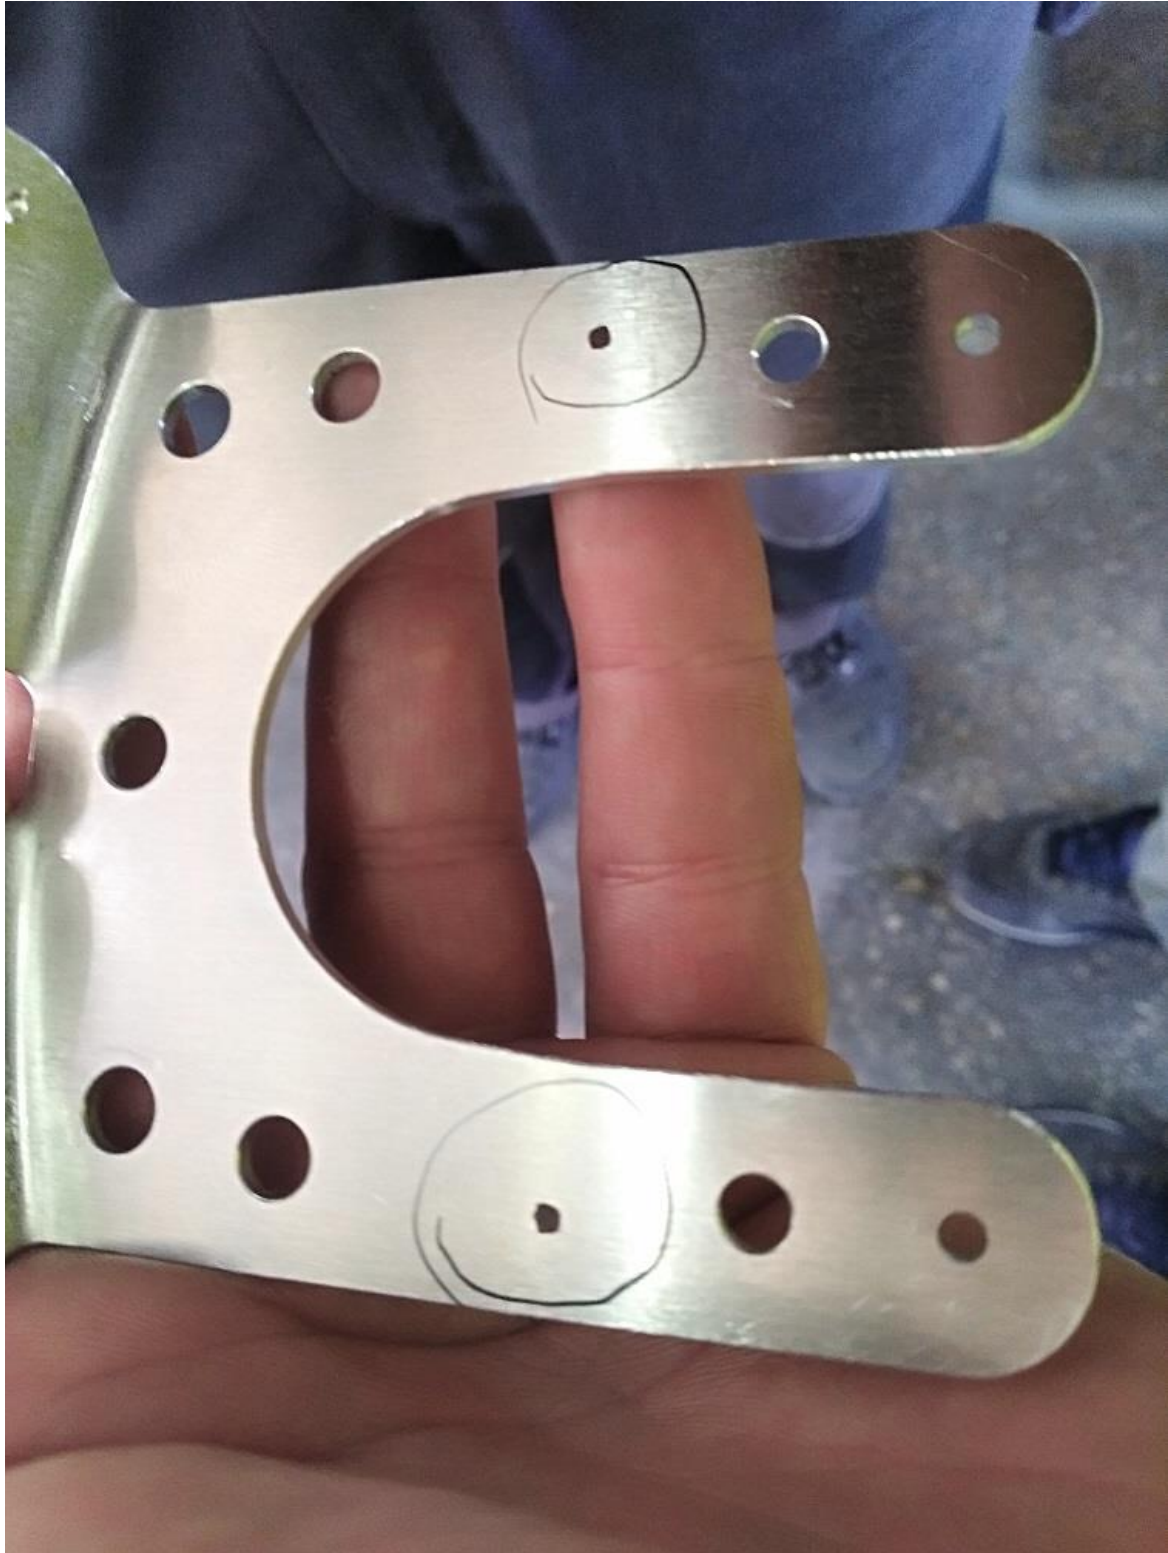
Fig. 9.

3.9) Mark with a marker the holes in the doubler through the holes in the fin spar (Fig. 9).

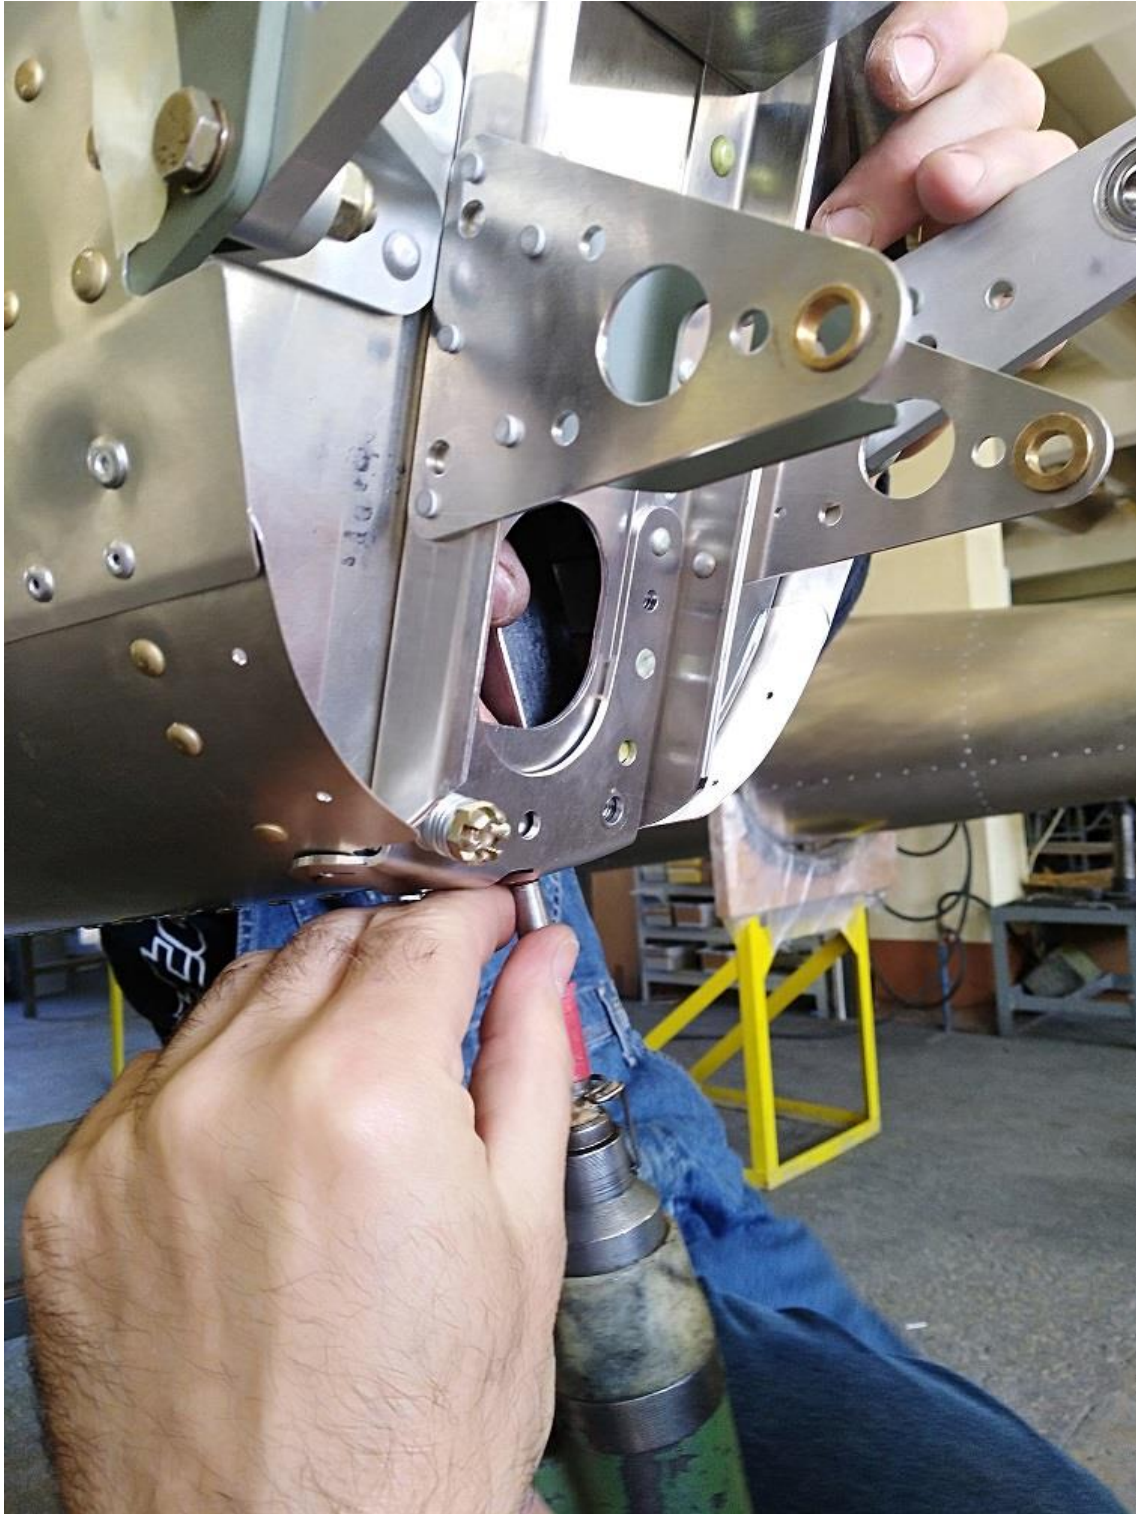
Fig. 12

3.12) Install the rivets on the flanges of the doubler (Fig. 12).
