AEROPRAKT SERVICE BULLETIN

№ SB A22LS-20

CHECK OF A-22, A-22L, A-22LS AND A-22L2 AIRCRAFT HARNESS SYSTEM ELEMENTS FOR CORRECTNESS OF INSTALLATION

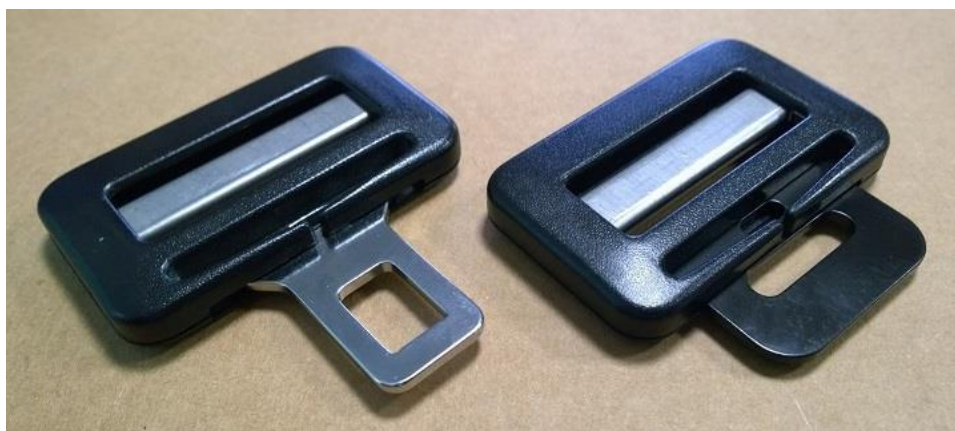
Photo 1

Serial number(s) affected: All aircraft with harness system buckles as shown on photo 1

Aeroprakt-22, Aeroprakt-22L, Aeroprakt-22LS and Aeroprakt-22L2 aircraft that have harness system with buckles as shown on photo 1

Incorrect placement of the buckles of the harness system.
