AEROPRAKT NOTIFICATION

No. N A32-17

HOLES IN THE FLAPERON HINGE AXLES IN A32 AND A32L AIRCRAFT

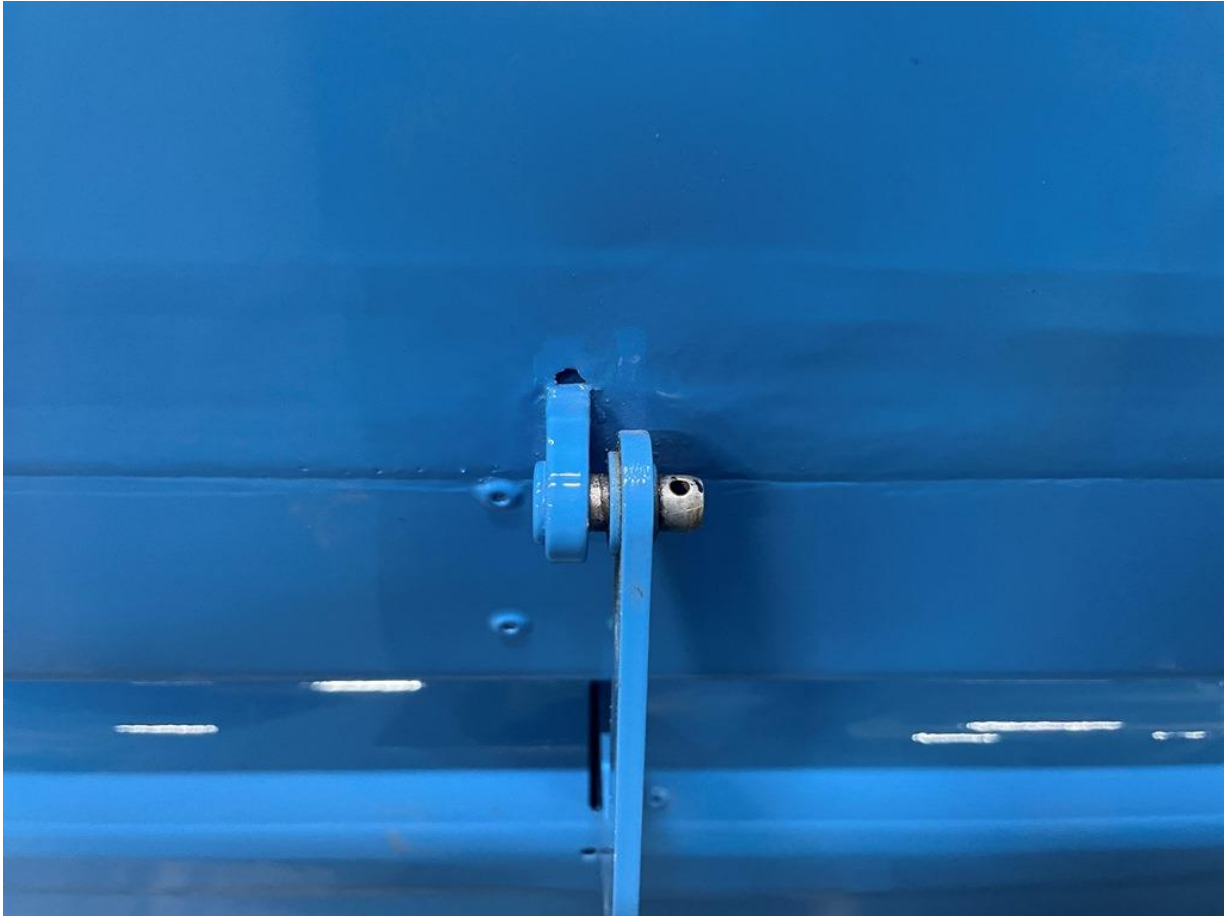
- Do not put any safety pins or wire in the holes in the flaperon hinge axles (see the photo below). It is a type-certified design. Failure to follow this instruction will invalidate compliance of your aircraft to the type design and type certificate.

- ◆ These holes are not intended for any safety pins or wire in the flaperon hinge axles. They are present because the flaperon hinge axles are made of a standard part (a pin with a hole for the safety pin/wire) the hole in which may be necessary for locking or safety pin/wire in other aircraft components. These holes in the flaperon hinge axles do not affect in any way or degree the normal function of the hinges.
