A32 VIXXEN / A22LS FOXBAT / KELPIE

Nose leg inspection recommendations

Serial number(s) affected: All serial numbers of A-22LS and A-32 aircraft.

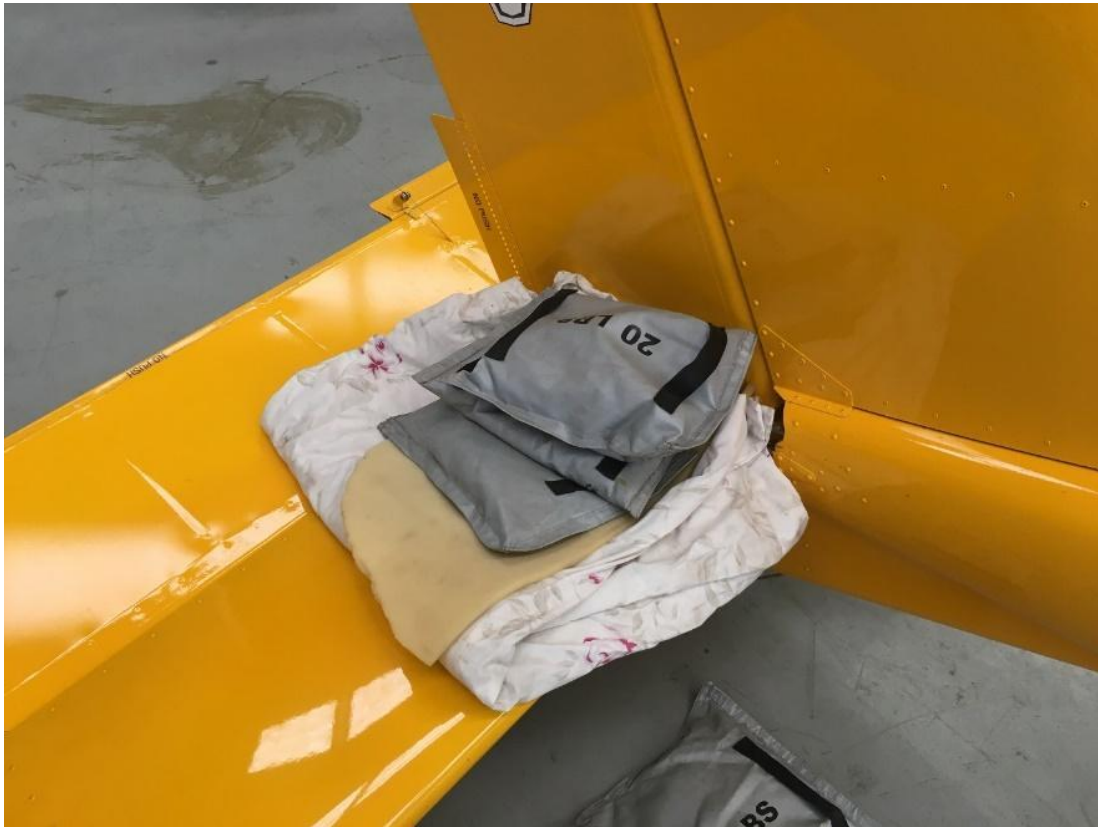
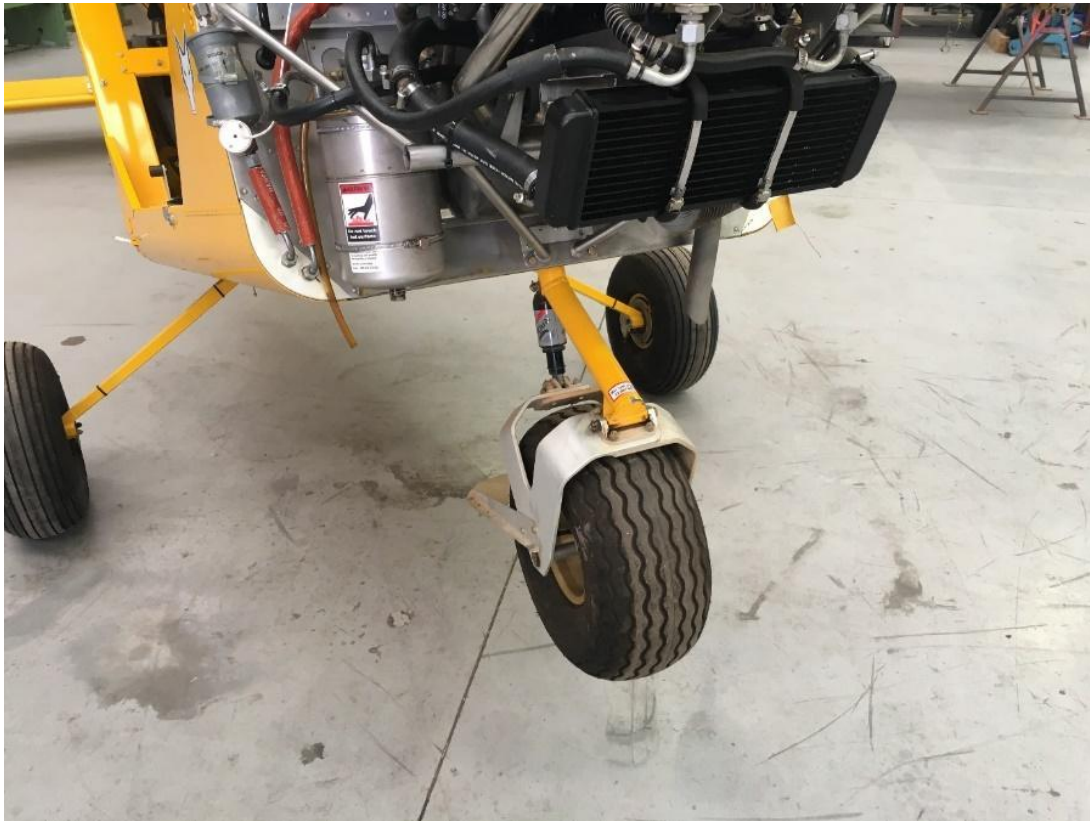
1. Lifting of the nose wheel can be done by either a jack at the recommended jacking point or with sand bags on a soft foam located at the root of the stabilizer or AFHT. The aircraft can sit on the tail wheel or rear skit in this attitude.

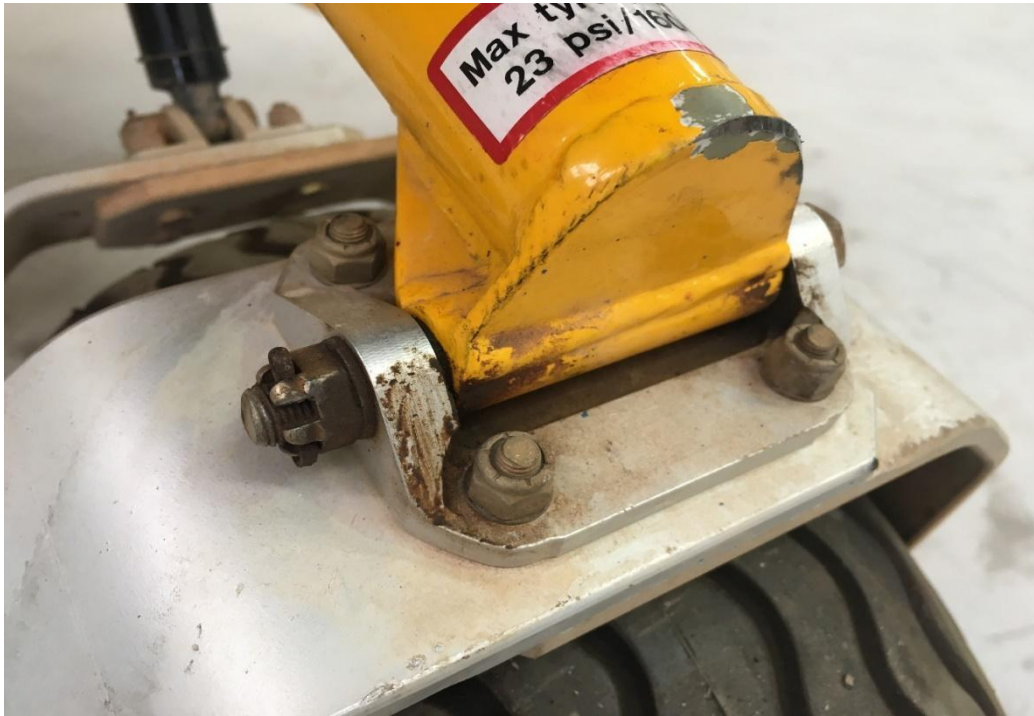
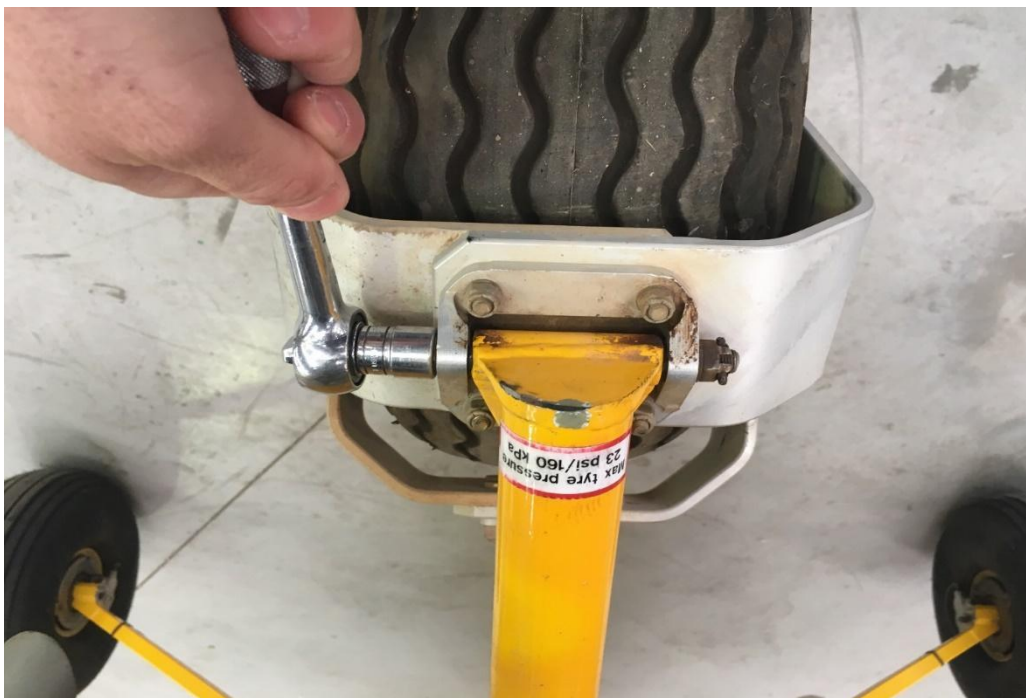
2. Make sure that the bolt is not seized by applying light pressure using the appropriate size spanner first, before removing it. If the bolt was seized, it is likely that large forces were exerted on the lower attachment bracket and therefore, must be inspected thoroughly for cracks and over stress damage.

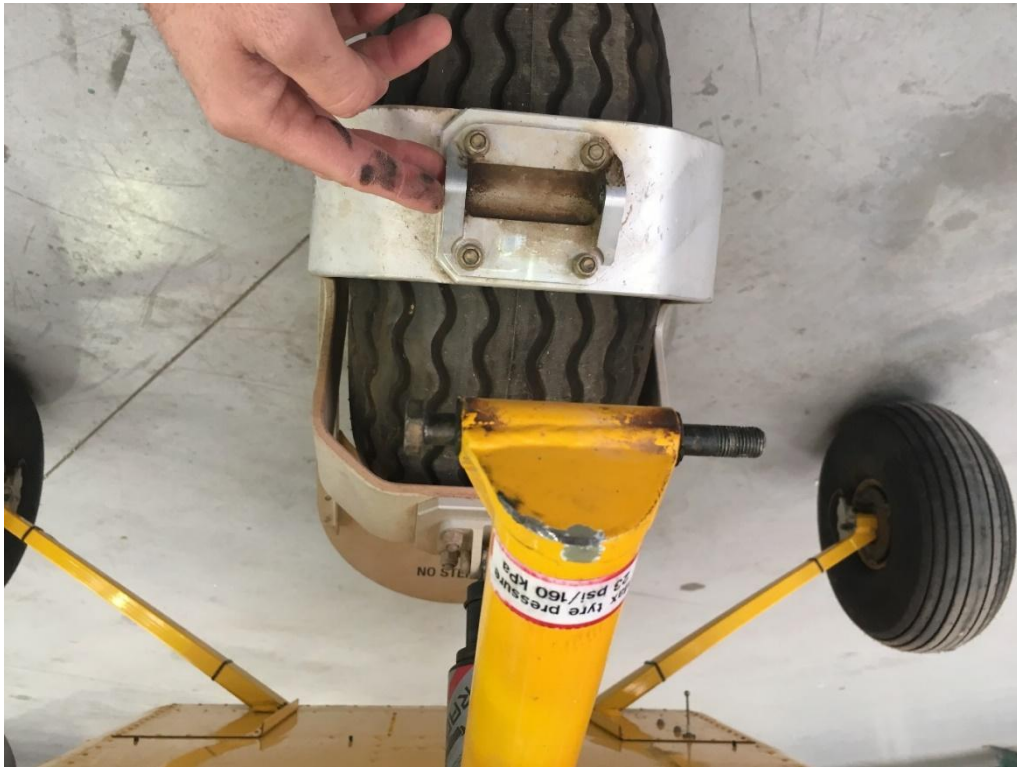
3. Remove the split pin, nut and bolt and carefully lower the leg and wheel to the rear.

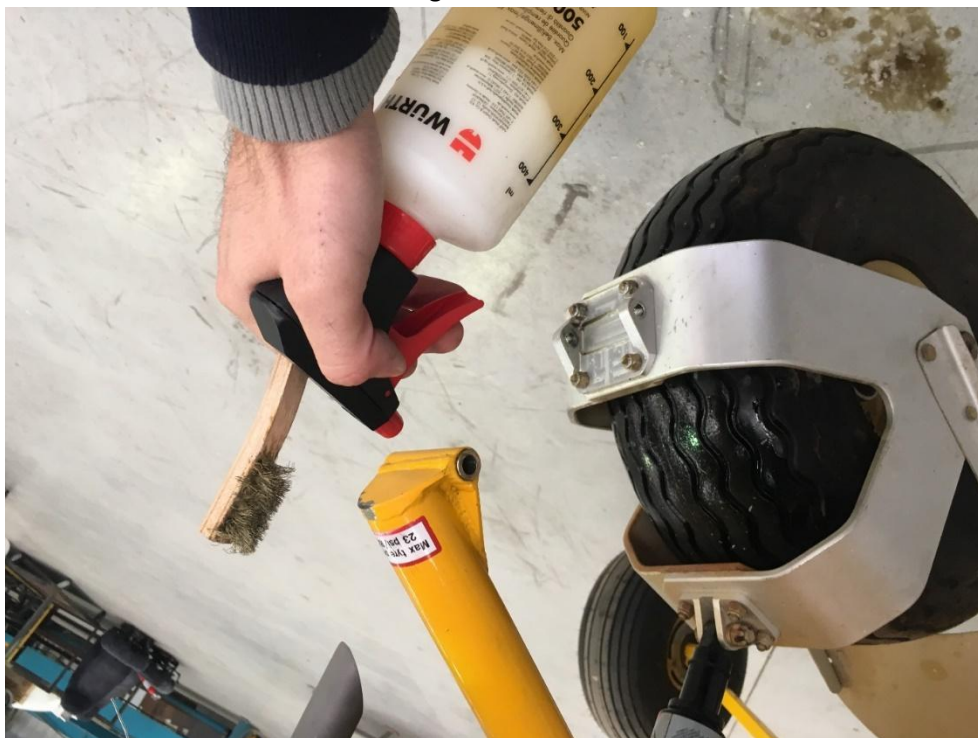
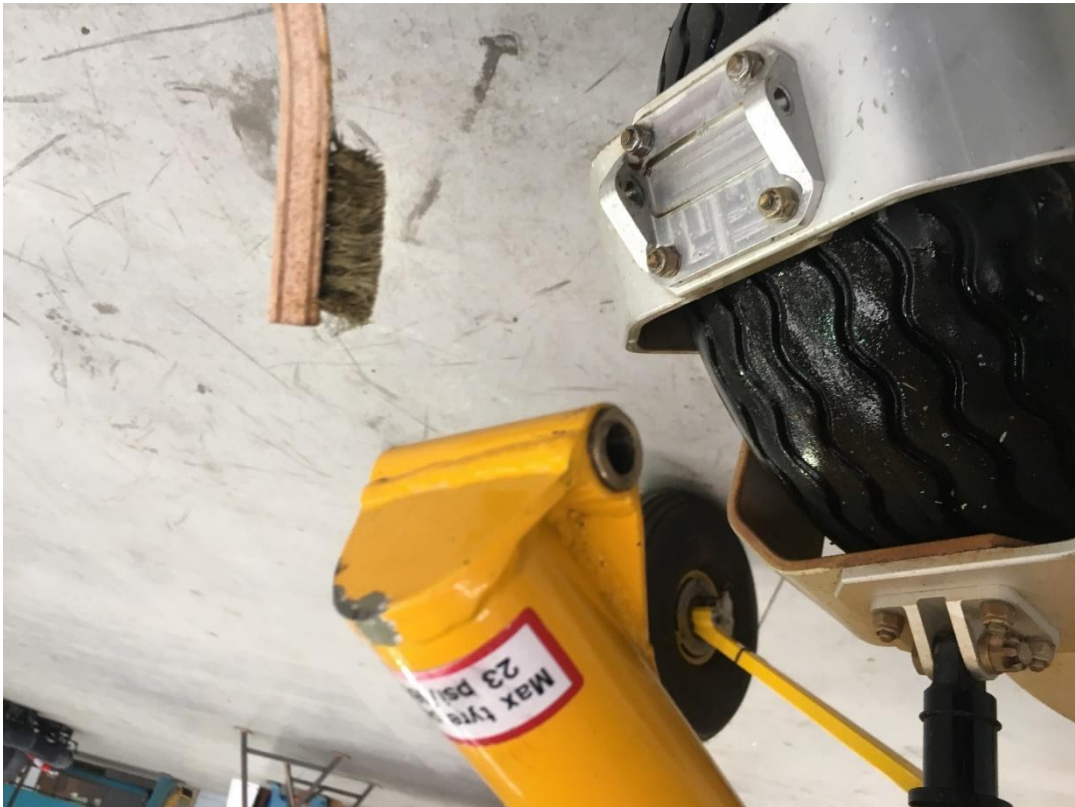
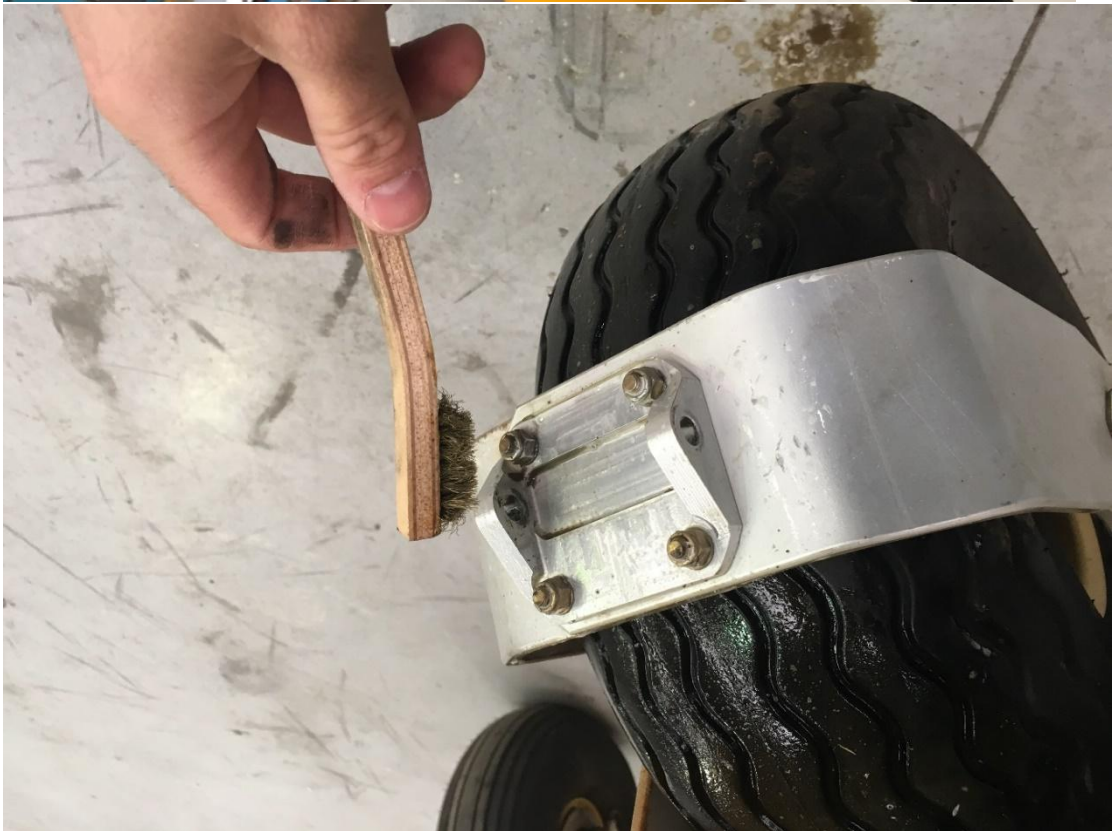
4. Clean the area using anti corrosive products and use a soft tool to agitate all dust and remove older grease deposit off the bracket and bolt, be careful not to damage the bronze bushes on either side of the nose leg.

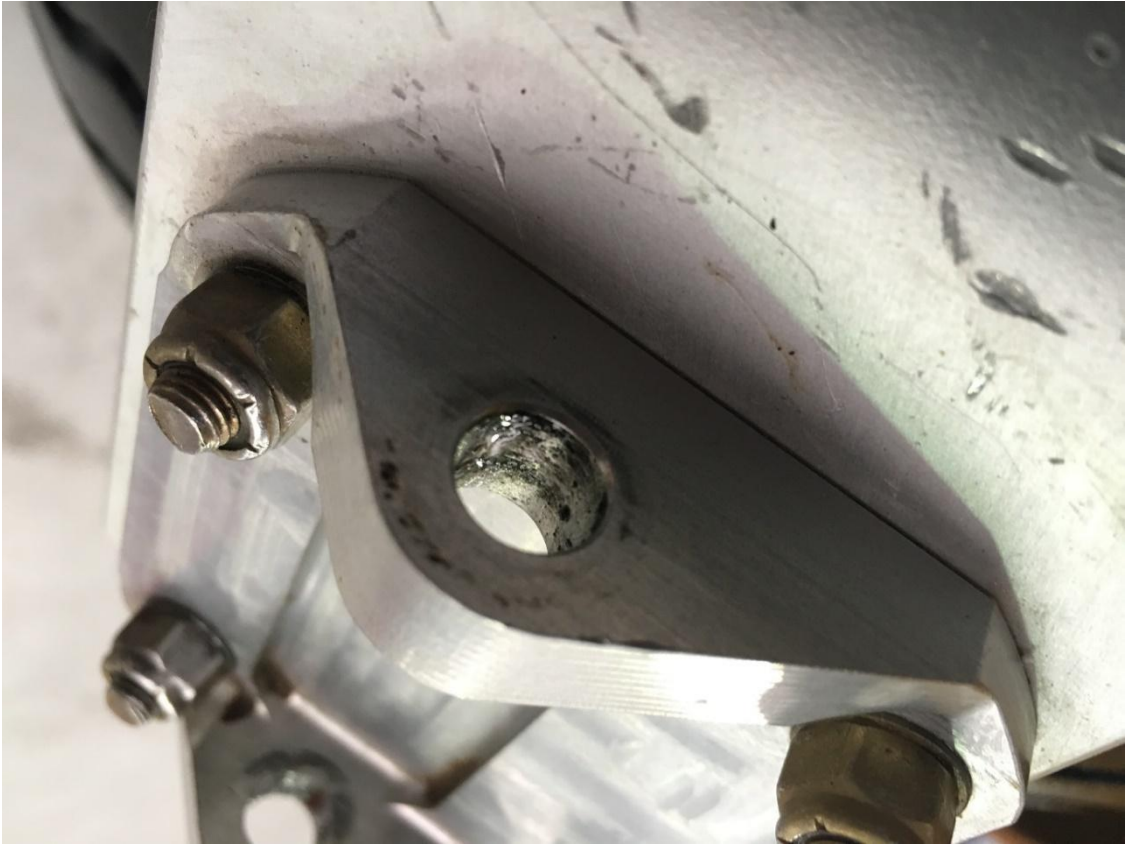
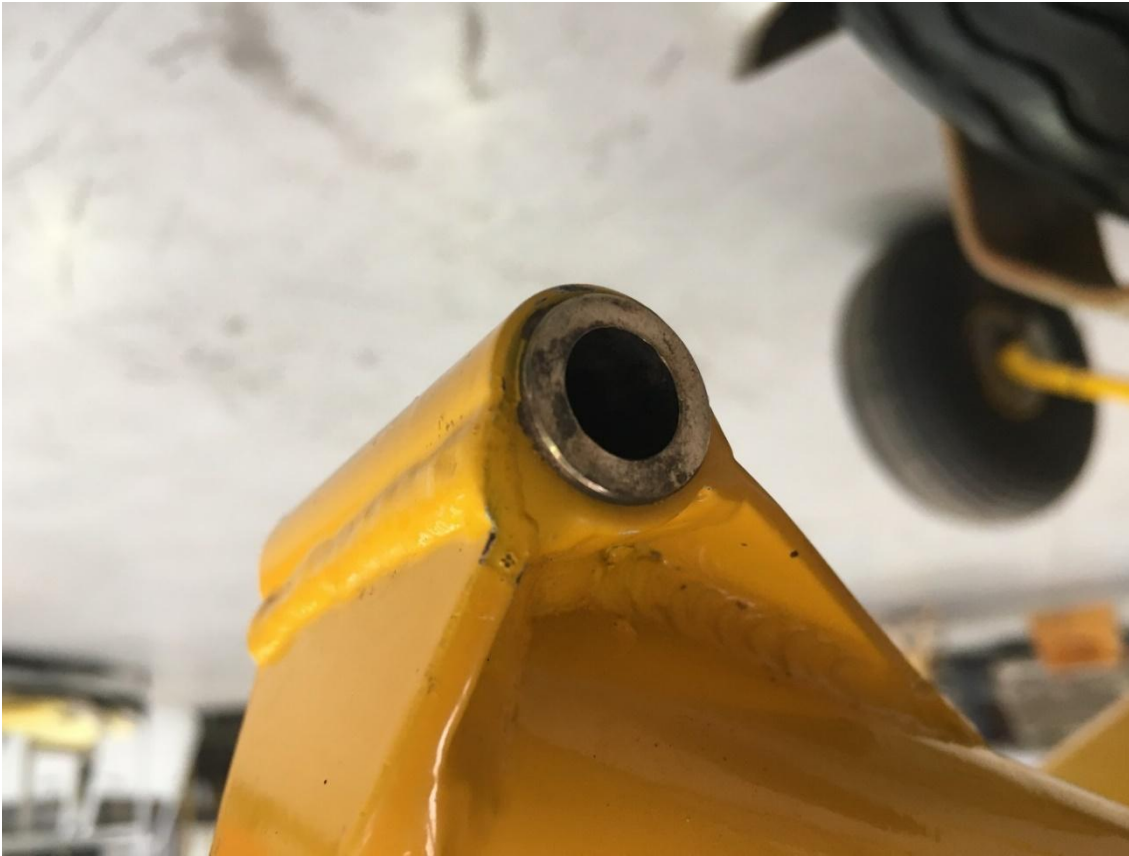
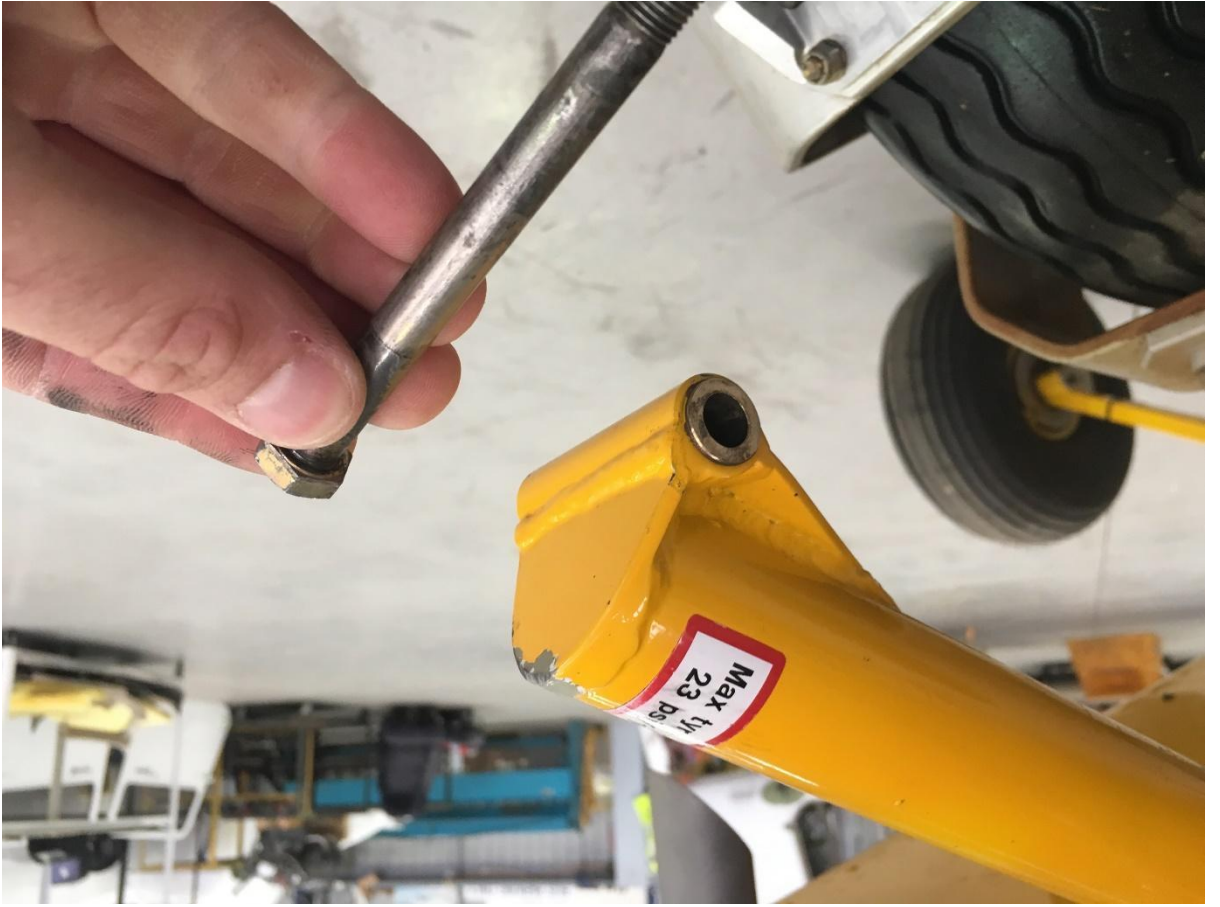
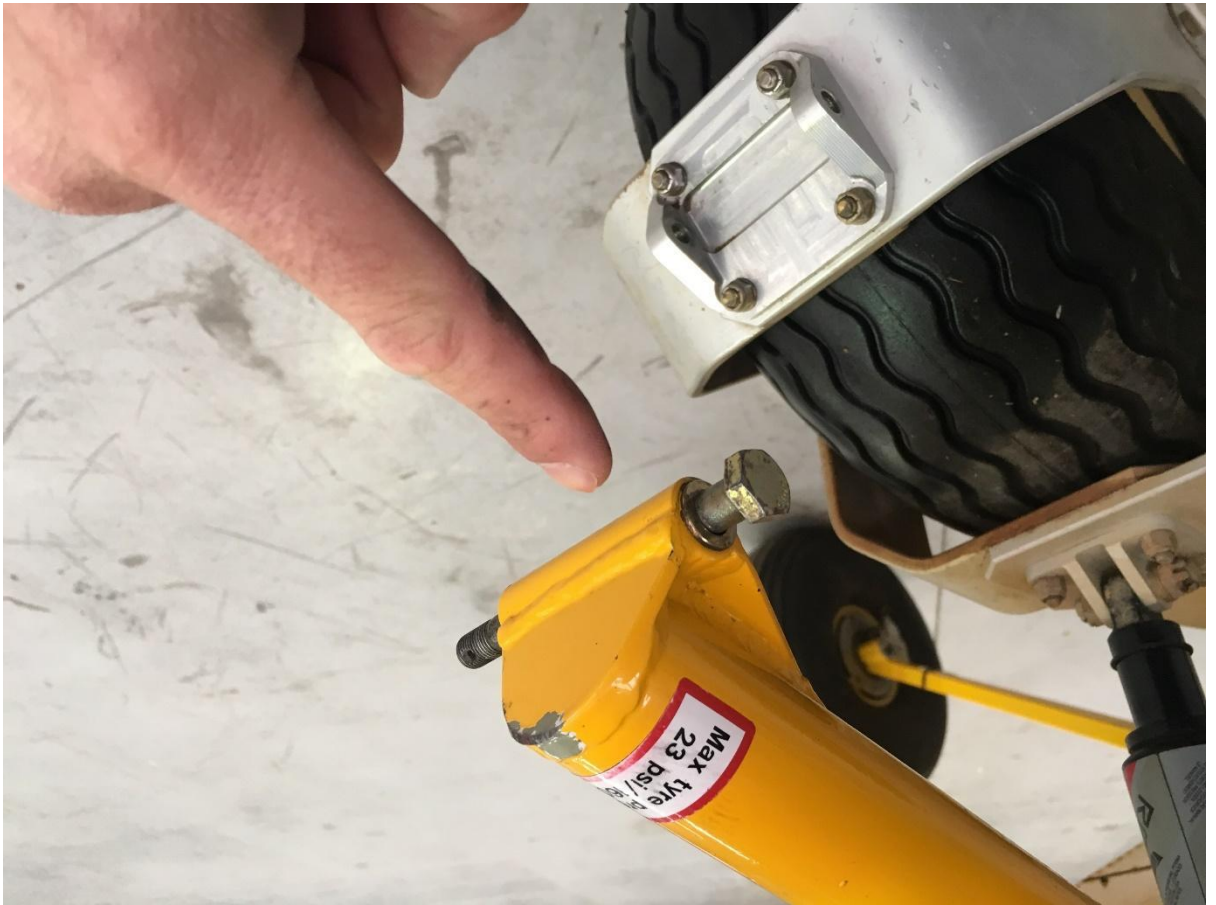
5. Once the parts are cleaned, perform a detailed inspection on the bracket and all attachment points, as well as the nose leg itself.

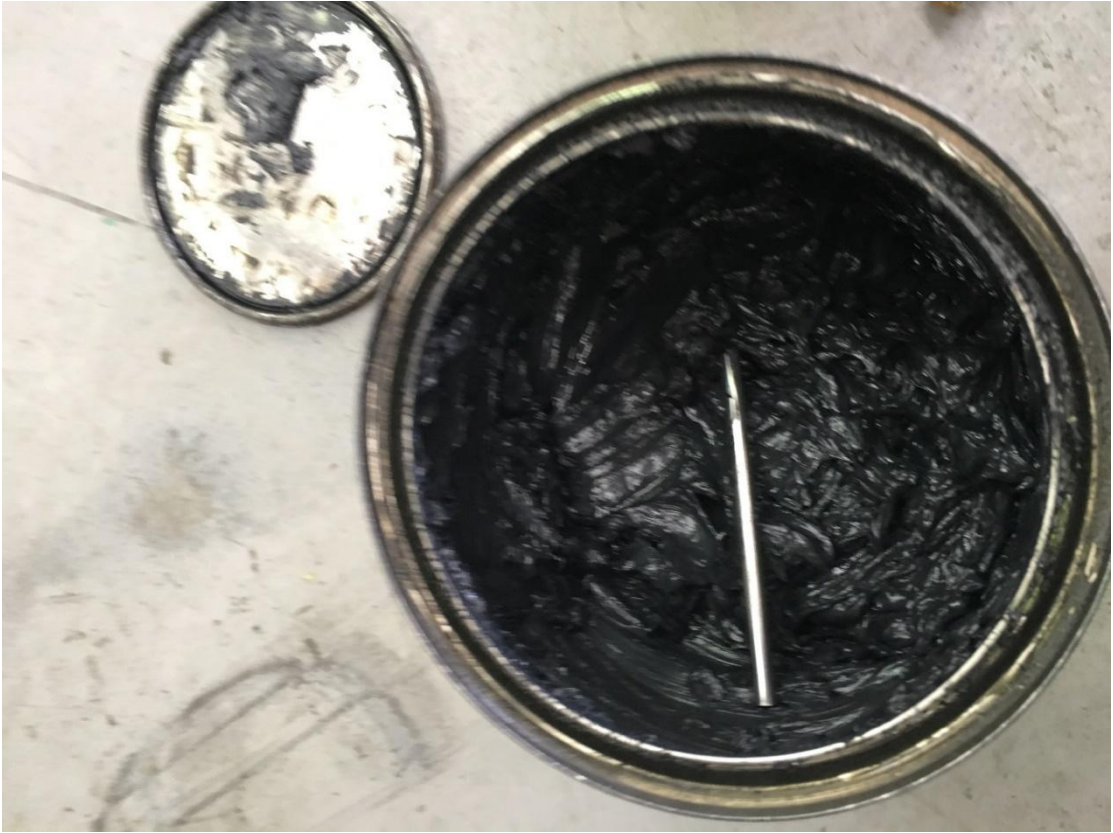
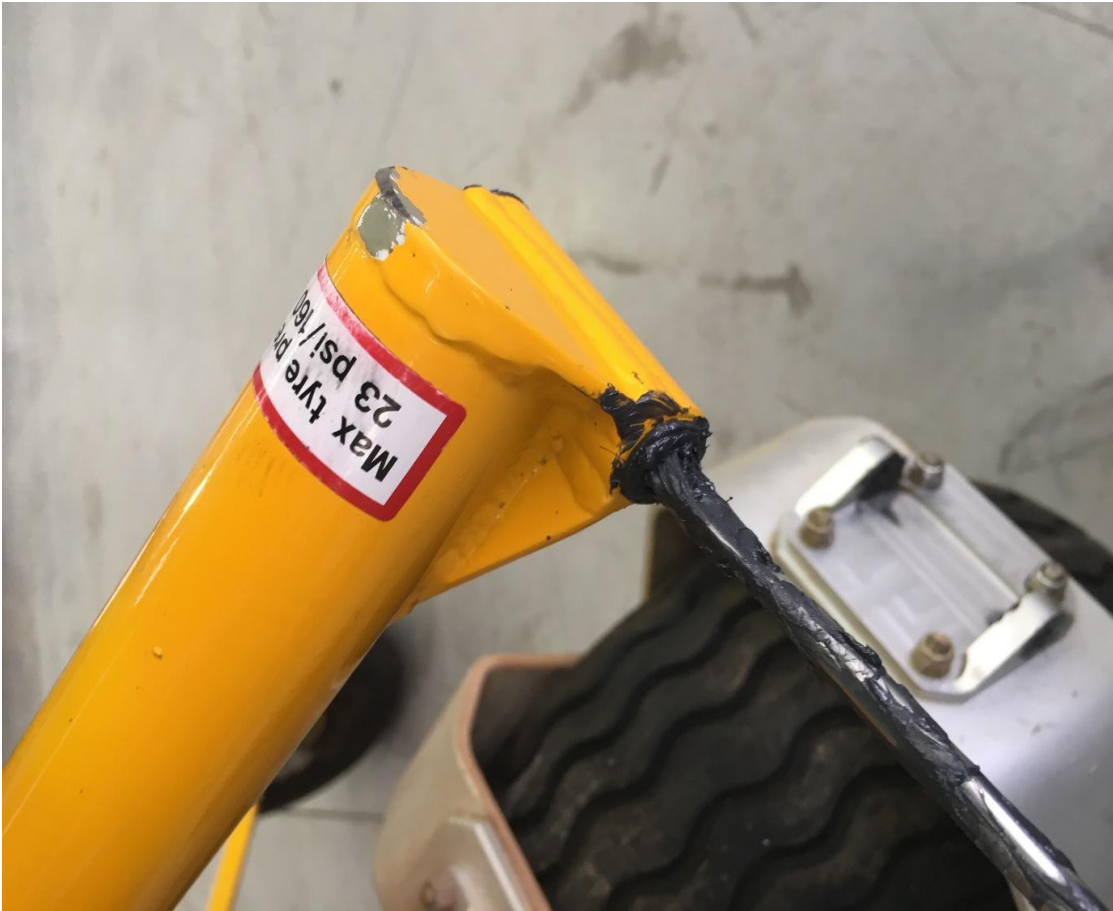
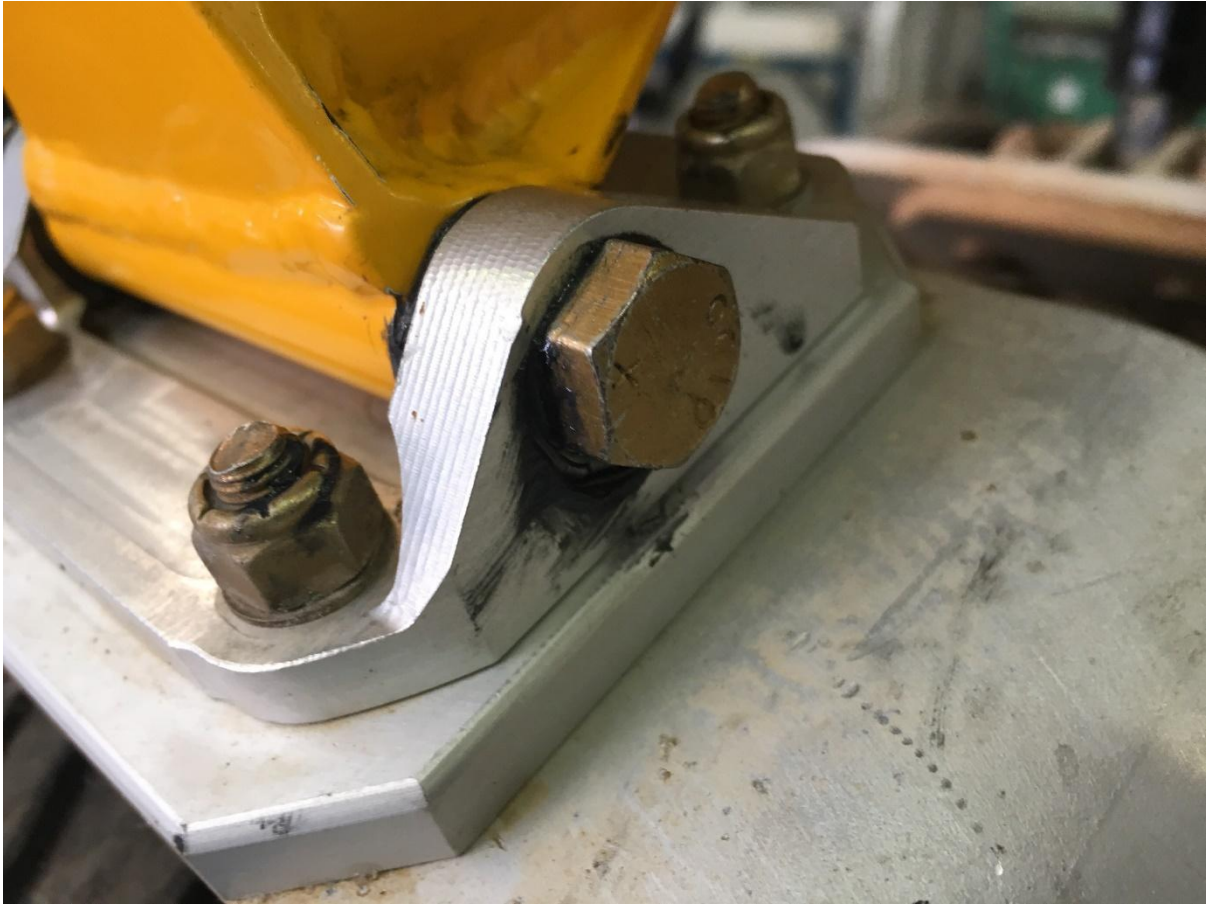
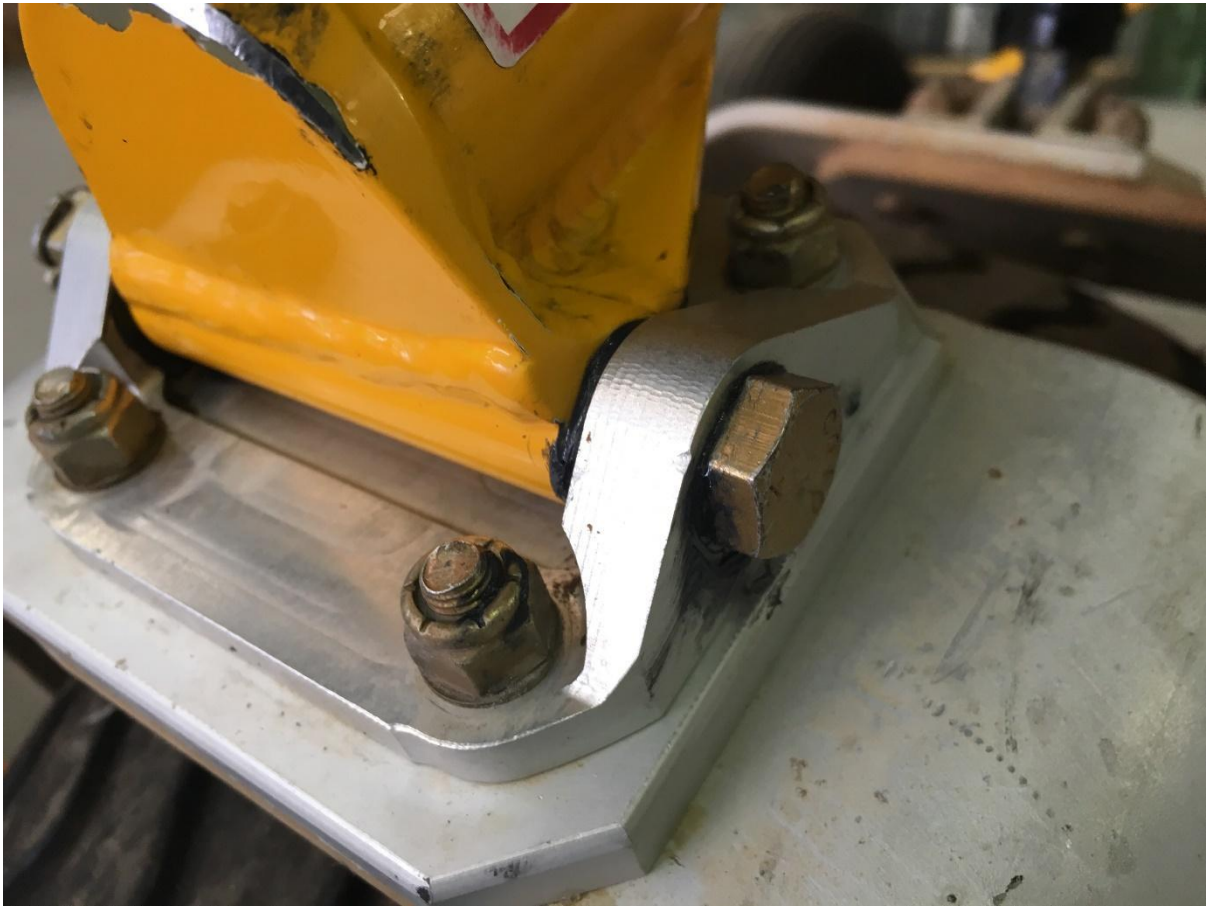
6. Before re-installation, use heavy grease with anti-moisture, anti-corrosion elements and insert inside the leg, apply on bolt and in all areas of movement.
