AEROPRAKT SERVICE BULLETIN

No. SB A32-07

REPLACEMENT OF THE NOSE WHEEL FORK HINGE BRACKET OF A32 AND A32L AIRCRAFT

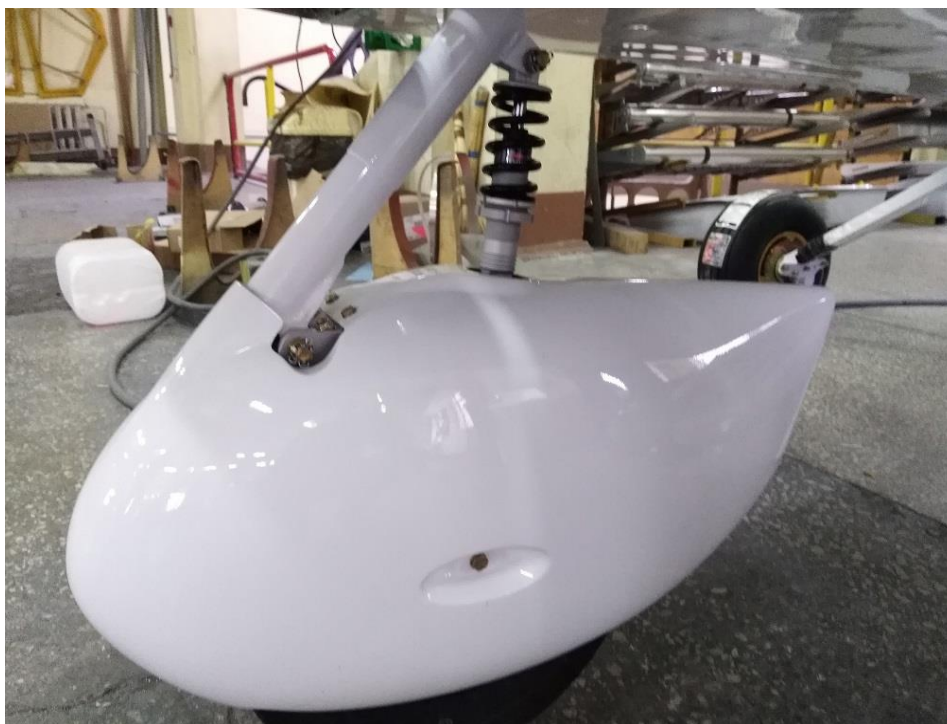
Photo 2

3.1) In case if the nose wheel spat is installed (Photo 2), do the following actions:

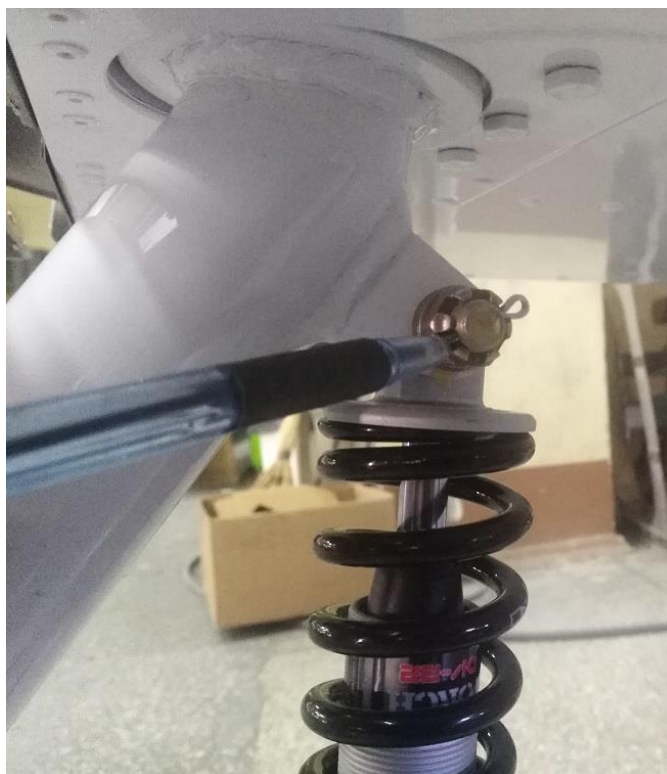
Photo 3

3.2) Remove the split pin locking the nut of the upper bolt attaching the shock absorber (Photo 3).

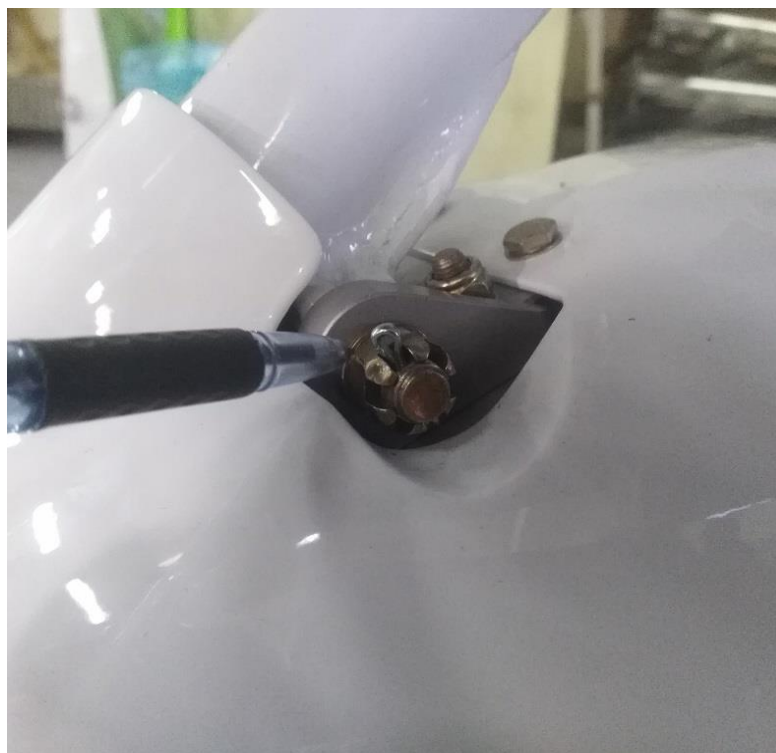
Photo 4

3.3) Remove the split pin locking the nut of the bolt attaching the wheel fork to the strut (Photo 4).

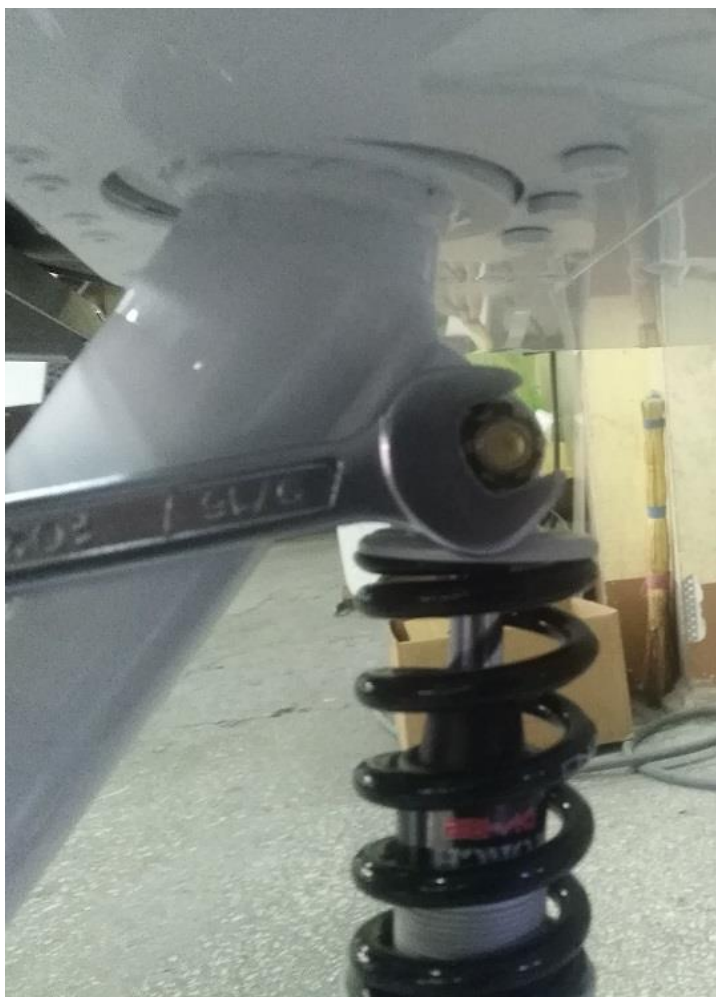
Photo 5

3.4) Undo the nut of shock absorber attachment using a 9/16 wrench (Photo 5).

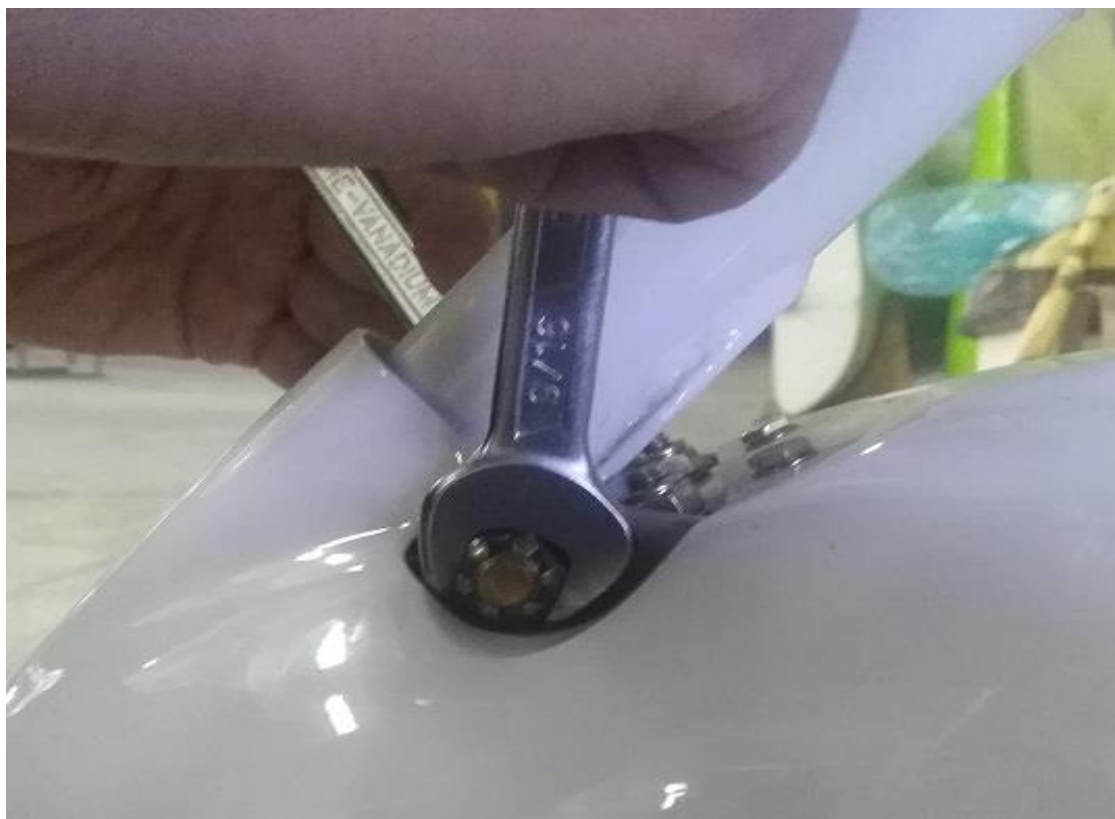
Photo 6

3.5) Undo the nut of wheel fork attachment to the strut using the 9/16 wrench (Photo 6).

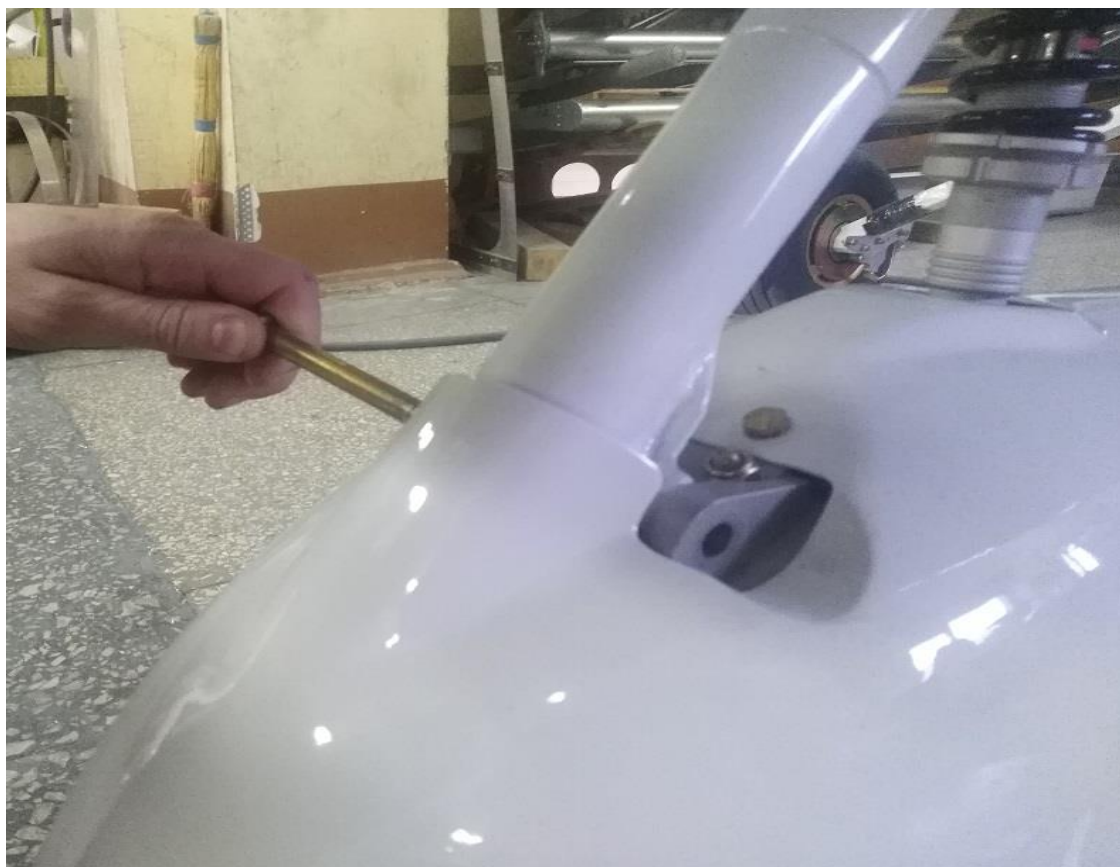
Photo 7

3.6) Remove the bolt attaching the wheel fork to the strut (Photo 7).

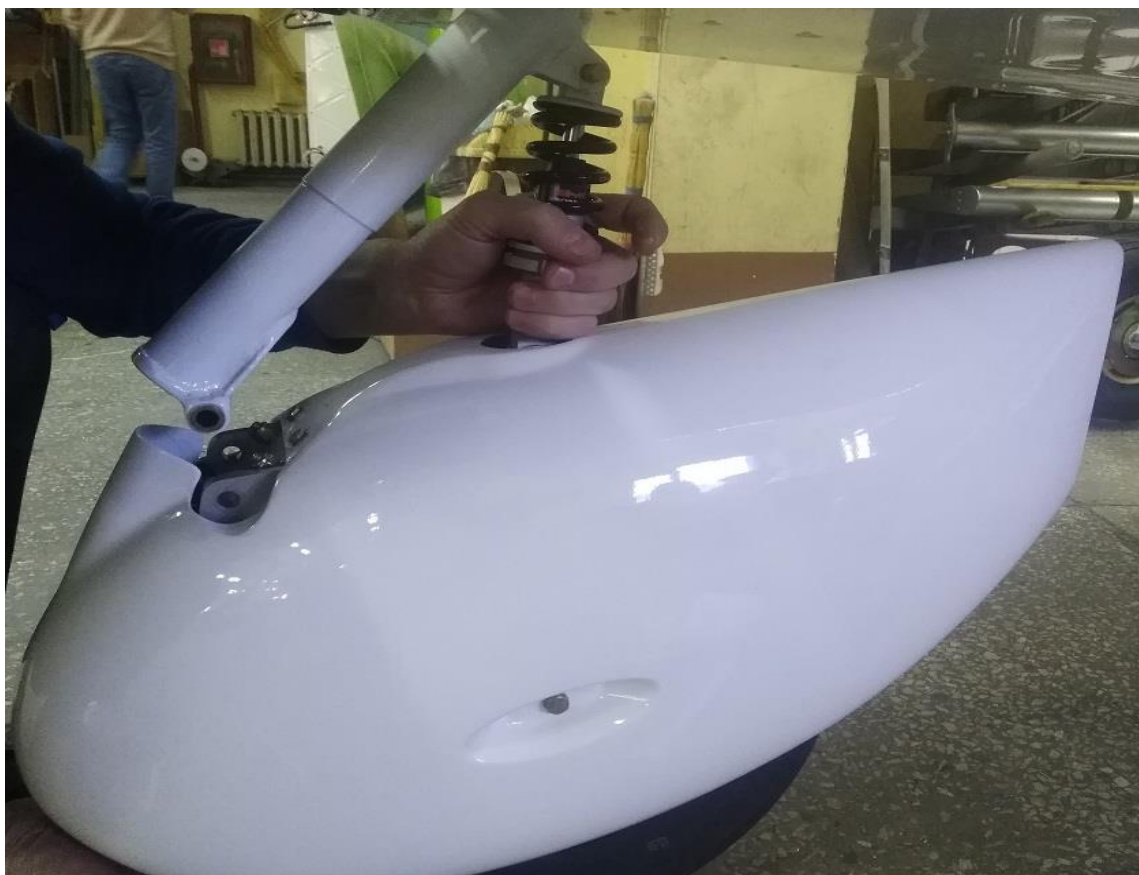
Photo 8

3.7) Remove the bolt attaching the shock absorber (Photo 8).

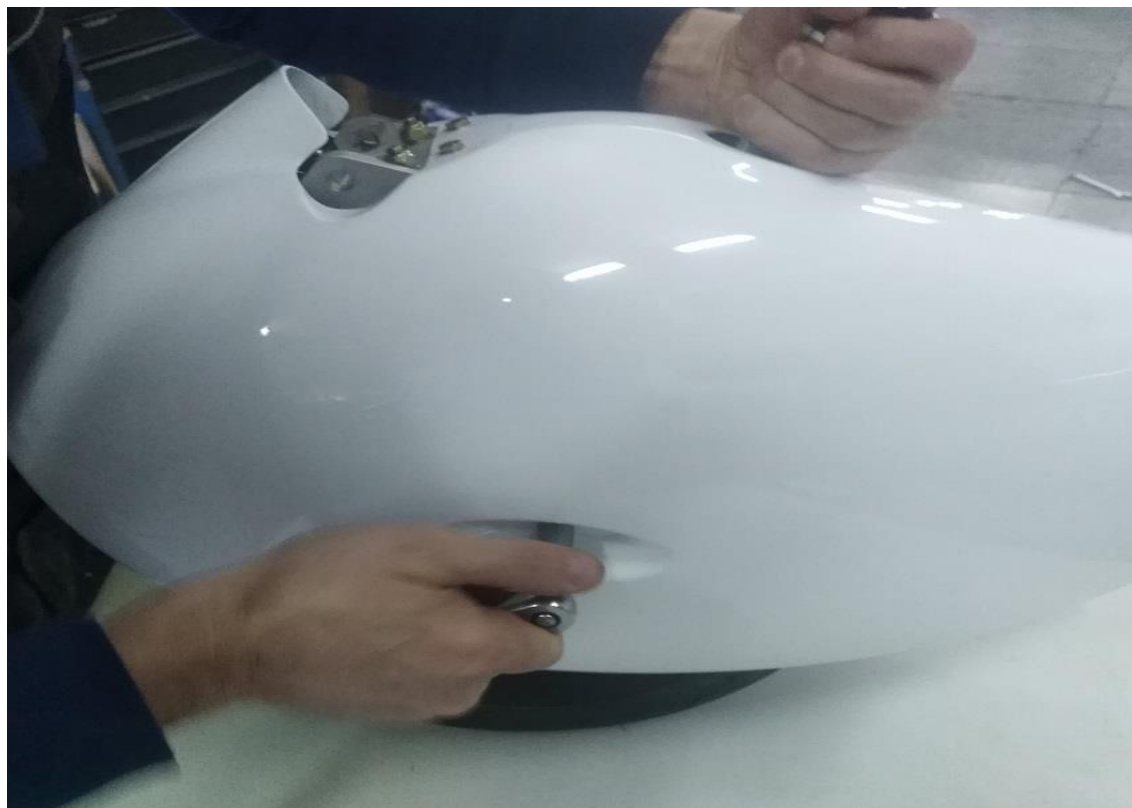
Photo 9

3.8) Undo 2 side bolts attaching the wheel spat to the wheel fork (Photo 9).

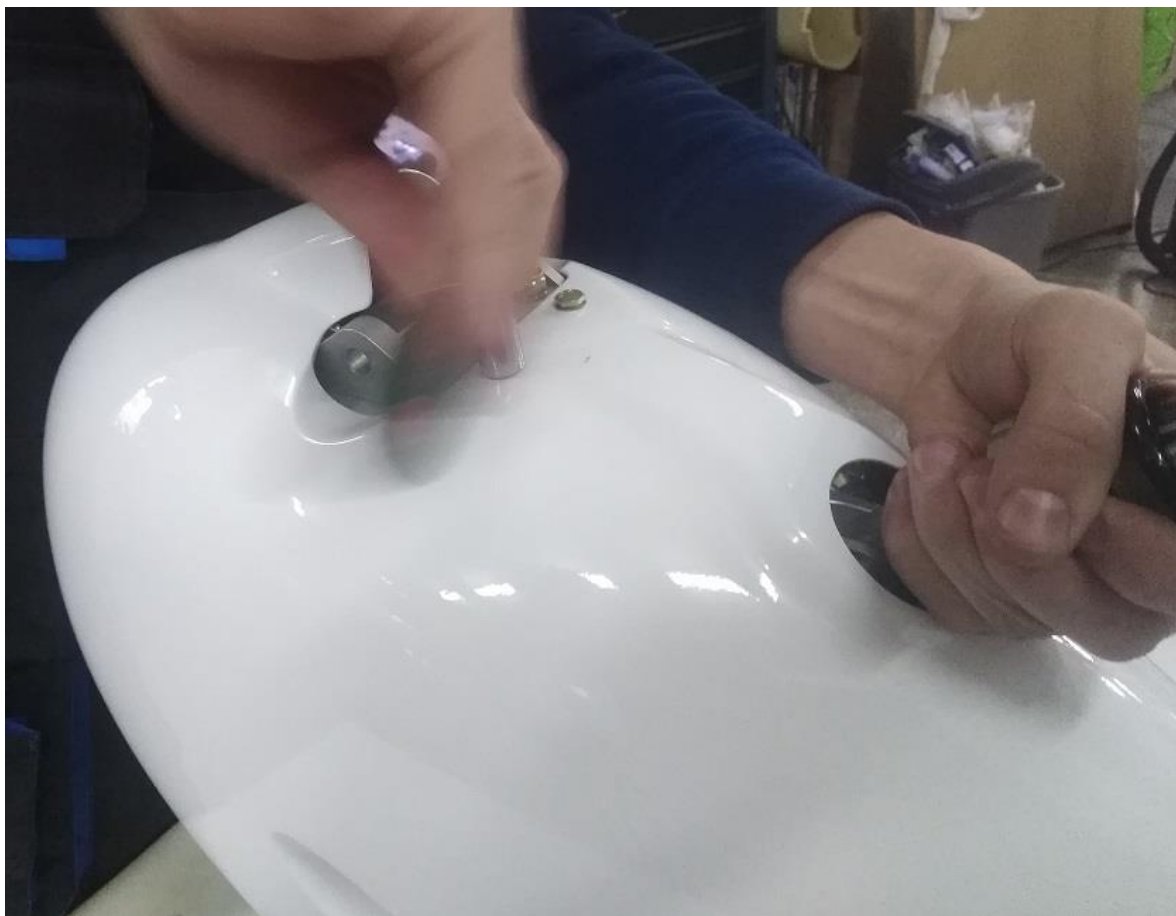
Photo 10

3.9) Undo 2 upper bolts attaching the wheel spat to the wheel fork (Photo 10).

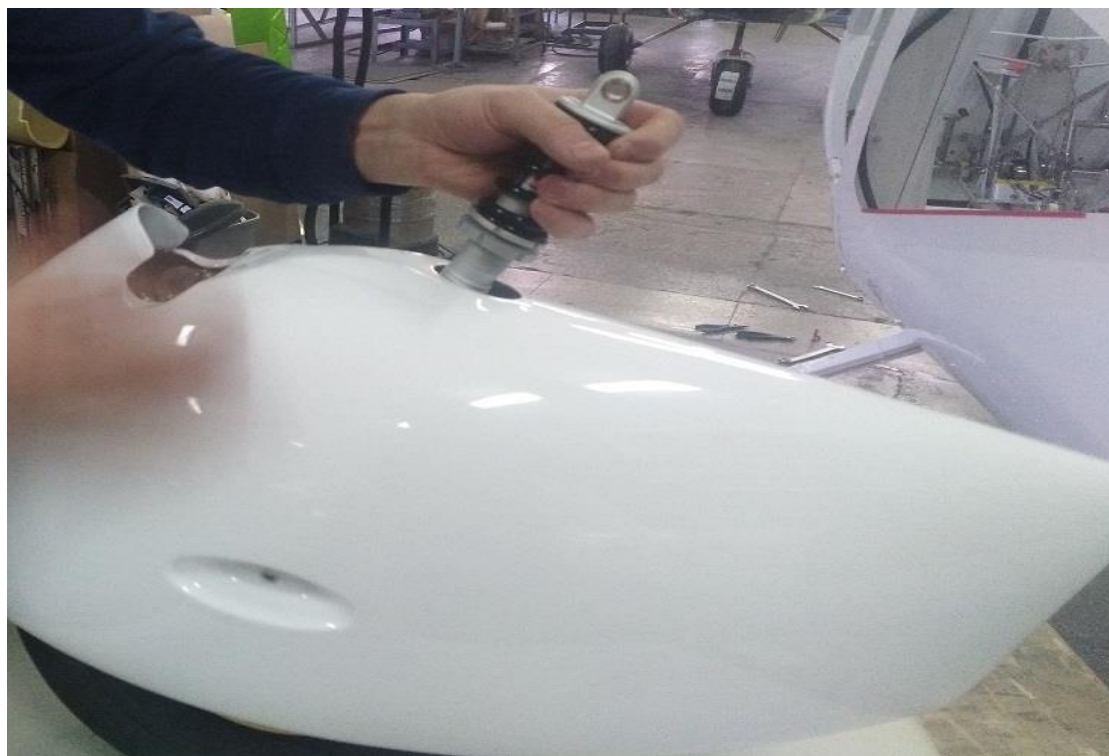
Photo 11

3.10) Remove the wheel spat up. Pass the shock absorber through the hole (Photo 11).

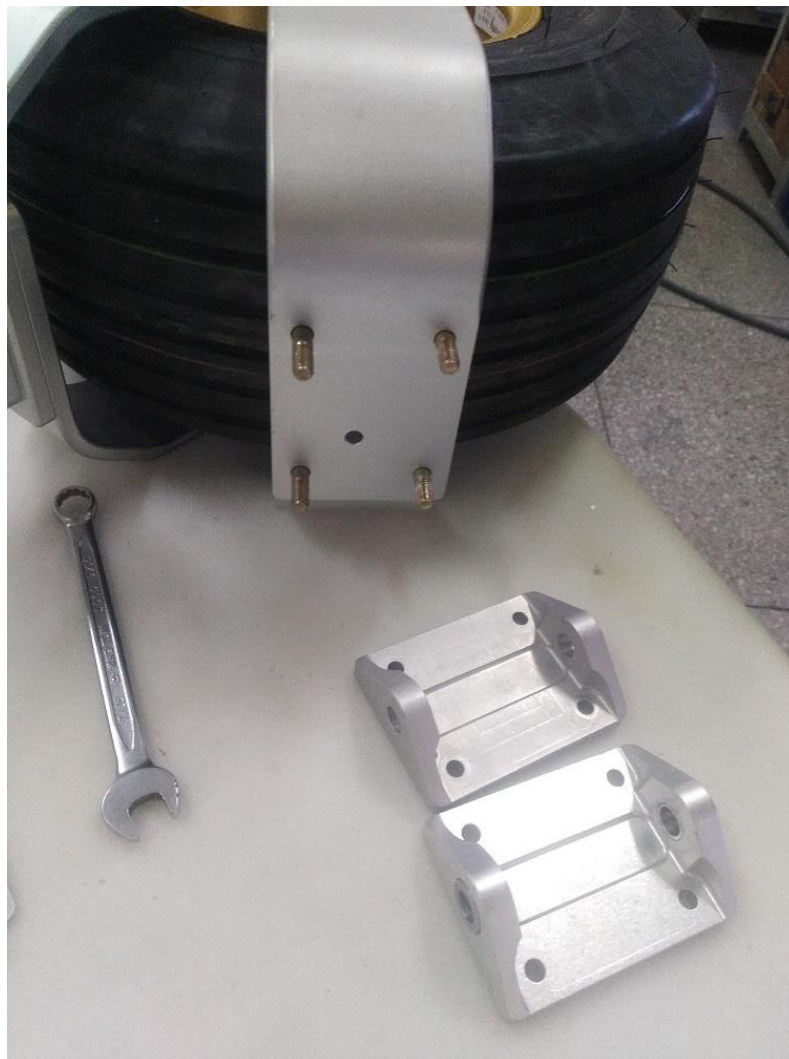
Photo 13

3.12) The bolts attaching the bracket may be left in place (Photo 13).
