AEROPRAKT INFORMATION BULLETIN

INSPECTION OF CARDAN RINGS AND AMMENDMENT TO AIRCRAFT MAINTENANCE MANUALS OF A-22LS AND A-22L2 AIRPLANES.

IB A-22LS-10

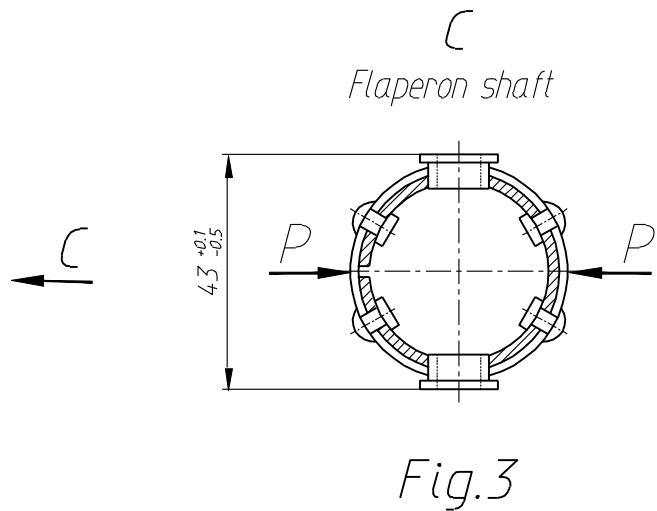
6. Removal of the deformation of the flaperon shaft must be done in vice with protecting pads. To ensure the required dimension of 43 mm between the outer faces of the bushings apply the squeezing force "P" (see fig. 3) to the shaft tube at right angle to the bushing axis.

7. Installation of the cardan ring and flaperon shaft must be performed in order reversed to the one described in steps 1-4. The nuts on bolts of the cardan ring must be done with torque 2 Nm (see 1.2).
